Localization of Noise Sources in Large Structures Using AE

David W. Prine, Northwestern University ITI, Evanston, IL, USA

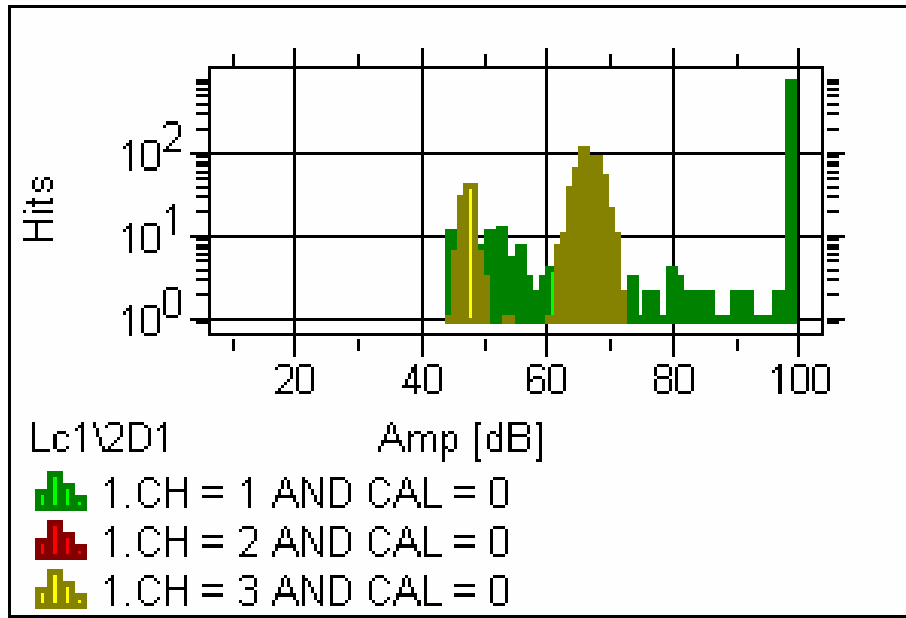
Figure 1 Amplitude Distribution for Closing of Left #2 Roof Segment

This bearing is typical of those tested. There is also structural noise which is consistent with high live loads caused by high bearing friction. Both figures 1 and 2 clearly show that the bearing is the noise source.

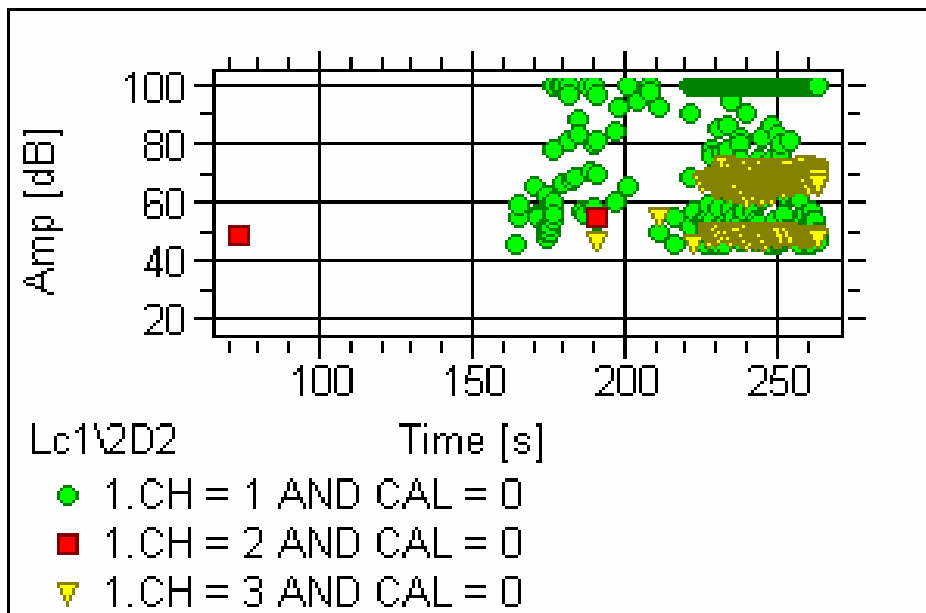
Figure 2 Peak Amplitude vs. Time for Closing of Left #2 Roof Segment

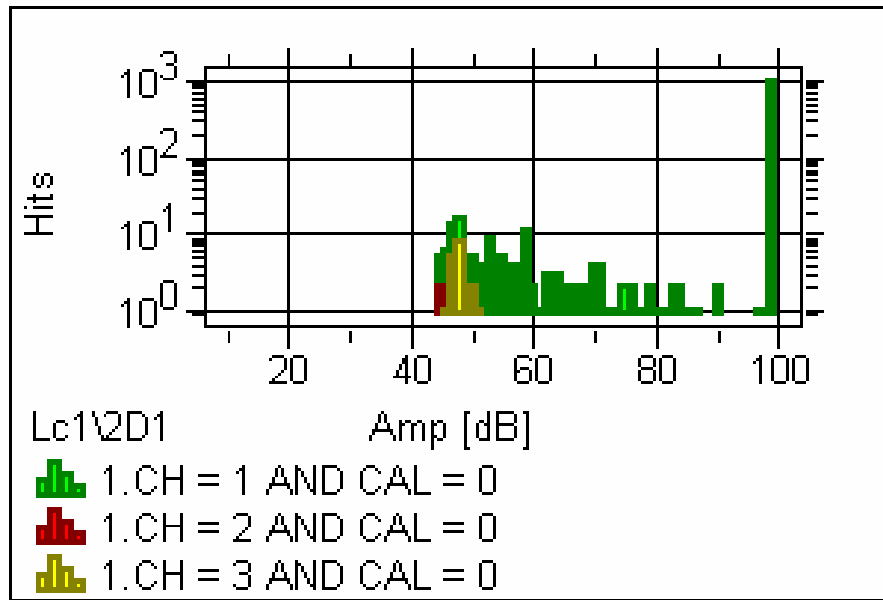
Figure 3 Amplitude Distribution for Opening and Additional Closing of Left #2 Roof Segment

These runs provide further clear confirmation of the bearing noise source. Additionally, this bearing during the opening cycle showed a clear correlation of displacement anomalies with large AE events. Figure 5 below shows a 0.3 second portion of the displacement between the roof truss and the bearing base plotted on the same time scale as the AE.

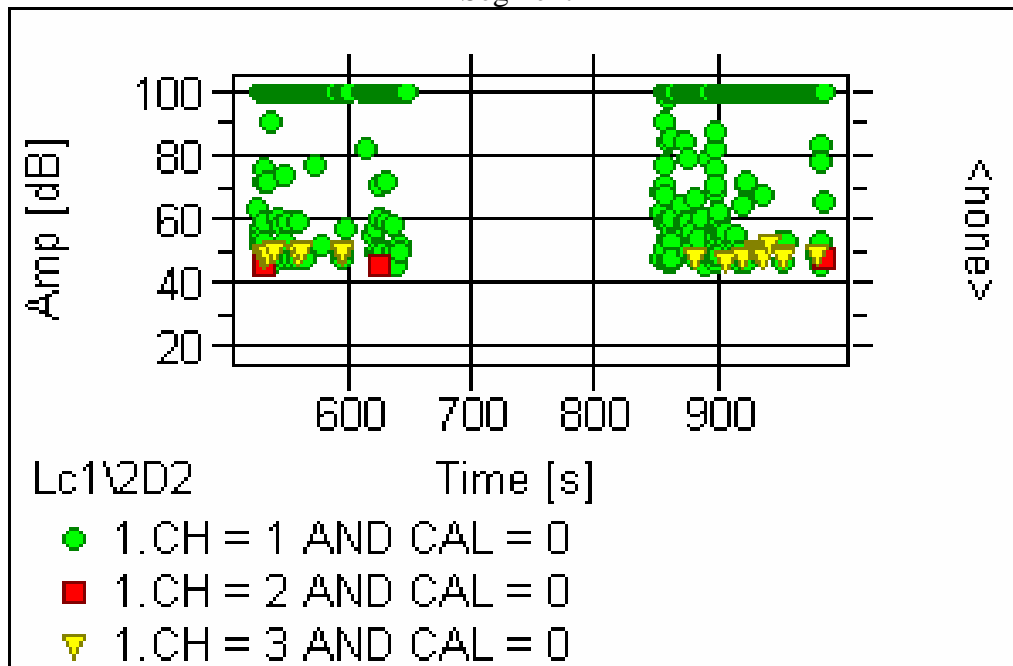
Figure 4 Peak Amplitude vs. Time for Opening and additional Closing of Left #2 Roof Segment

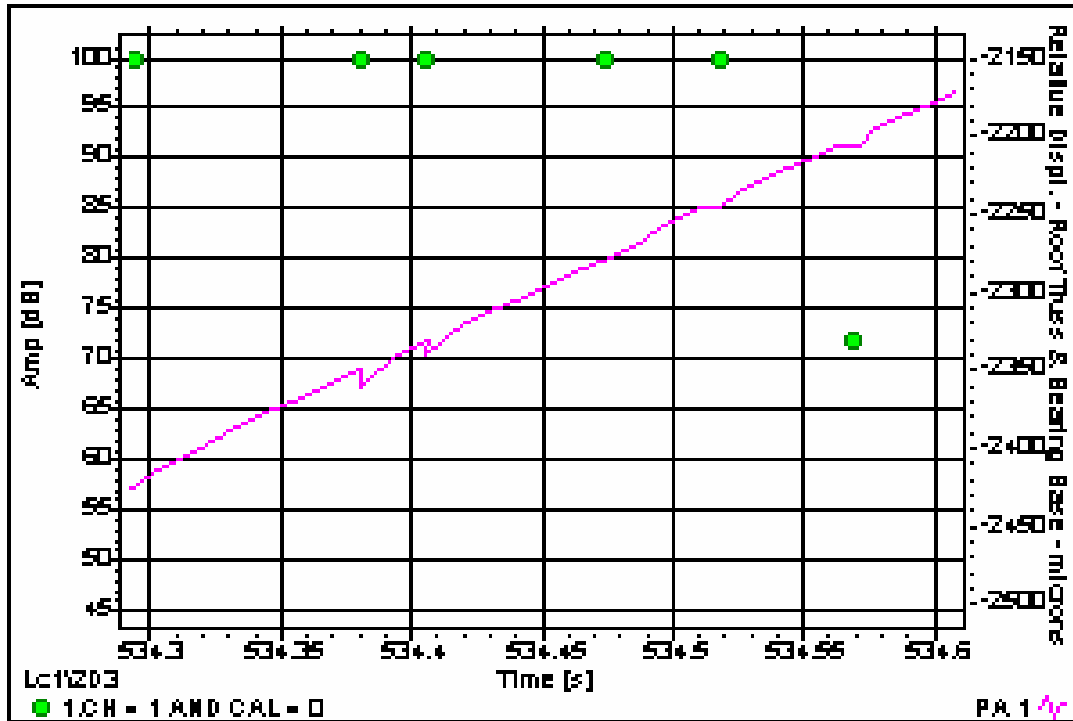
Figure 5 Showing AE Peak Amplitude and Displacement of Truss Relative to Bearing Base on Same Time Scale for L2 Bearing

Four out of five of the bearings produced significant noise but only two (L2 and R2) showed positive correlation between displacement and high amplitude AE events. Difficulties in aligning the sensors with their very limited range was the cause of this problem. Figure 6 shows the displacement data and AE peak amplitude for bearing R2 for a 0.30 second interval. Both sensors for the R2 bearing show transient movement that correlates with high amplitude AE. The frequency response of the displacement sensor is not sufficient to show an accurate representation of the transient movement. However, the sensors clearly show discontinuities in the time-displacement plot which correlate with high amplitude acoustic events.

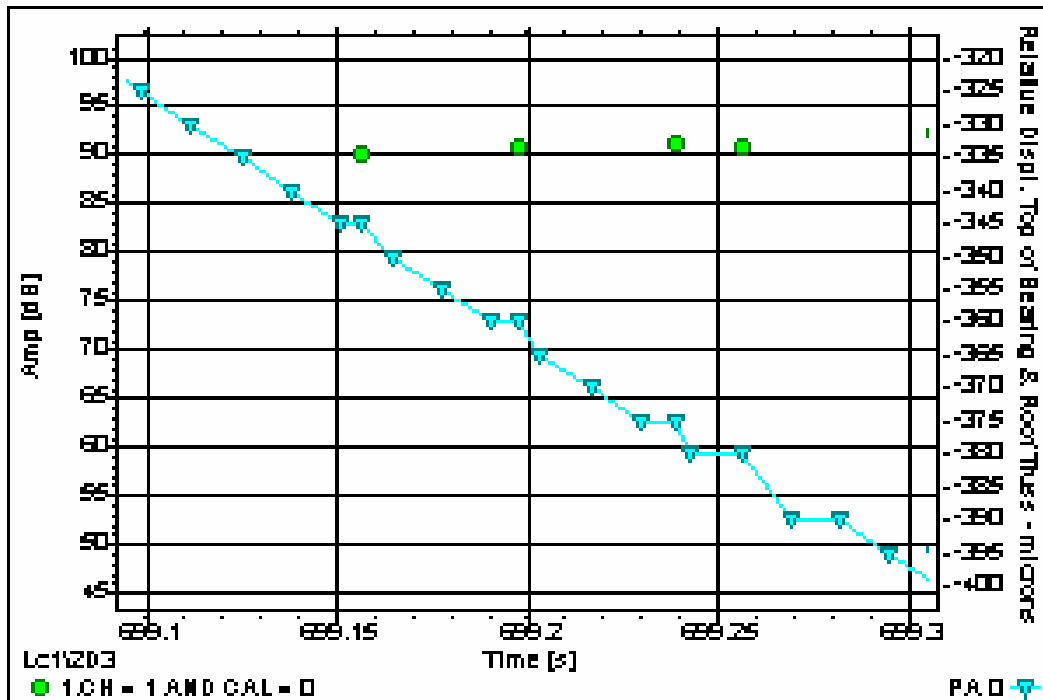
Figure 6 Showing AE Peak Amplitude and Displacement of Truss Relative to Bearing Top on Same Time Scale for R2 Bearing
