Florida SR-66 Sinkhole Monitoring
April 2005 Field Trip Report

David E. Kosnik, EIT
Infrastructure Technology Institute
Northwestern University
Evanston, Illinois

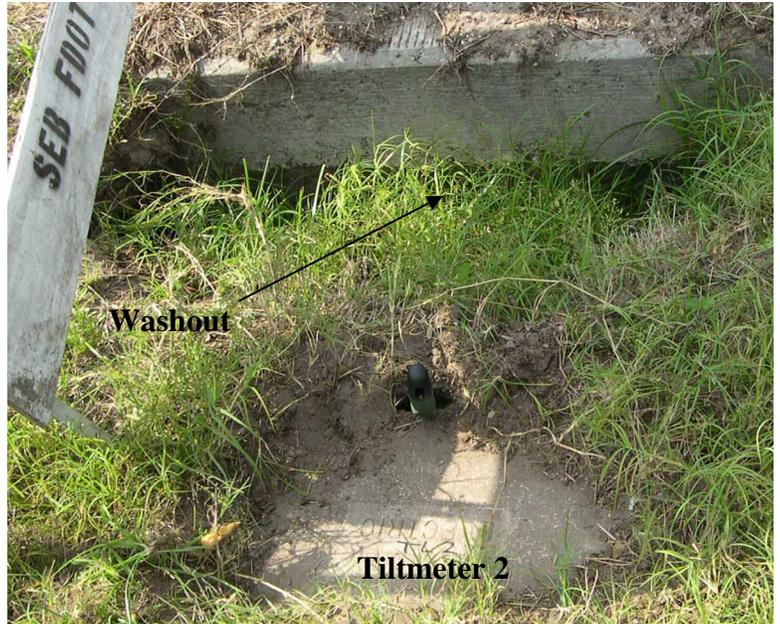
We found two washouts on the south side of the land bridge. The east washout is the larger of the two and extends at least 12” below the bottom of the land bridge girder. The west washout extends at least 4” below the bottom of the land bridge girder and lies between the land bridge girder and tiltmeter 2.

Examination of the washouts with a probe suggests that the washouts drain water from the land bridge deck down into the sinkhole. It does not appear that any kind of intermittent stream flows under the bridge through the washouts as was feared. Rather, water appears to drain straight down into the sinkhole. This is consistent with the hypothesis that the sinkhole is of a deep, narrow “chimney” type.

We highly recommend that FDOT send an engineer in the manhole to inspect under the bridge, especially given the formation of washouts on the shoulders of the land bridge.

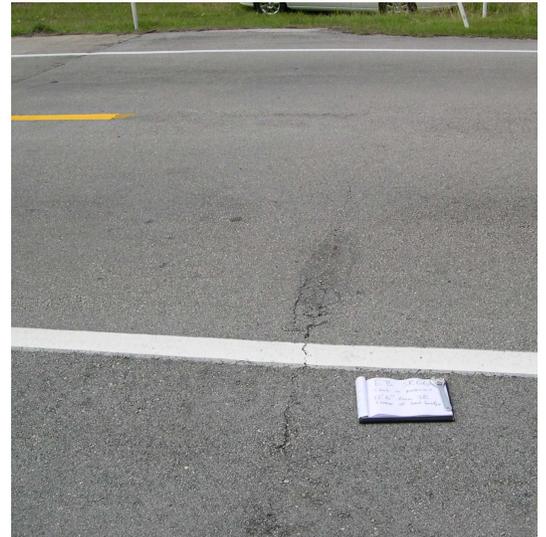
FDOT personnel pointed out that the road had been resurfaced recently, and that the resurfacing crew had been advised of the conduit crossing the road. However, we found a crack in the pavement suggesting that the conduit had been nicked or crushed during resurfacing. The location of the crack is consistent with the location of the kink in the TDR waveform.

If FDOT wishes to restore this site to full working order, the inoperative tiltmeters will need to be replaced. In addition, a crew will need to replace the conduit and TDR cables under the road that were damaged during repaving.

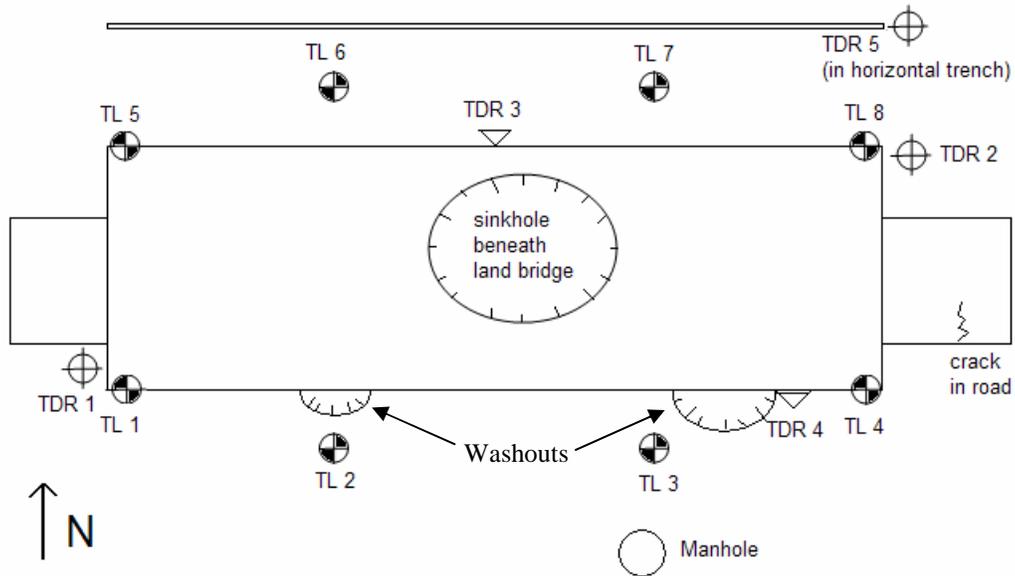
Drawing not to scale. Distances are as follows:

- 32' from SW corner of land bridge to west washout
- 25' from SE corner of land bridge to east washout
- 12' 6" from SE corner of land bridge to crack in road

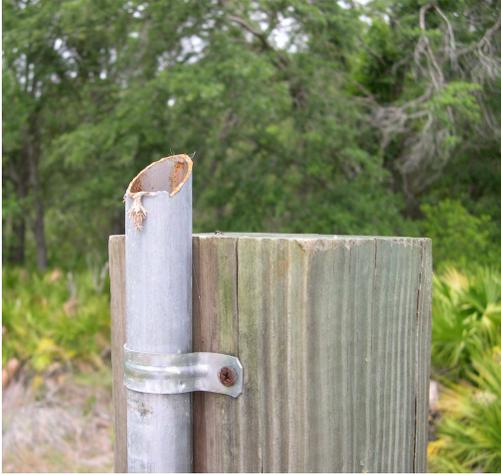
Solar panel stolen from pole

An FDOT crew installed a 30-foot mast on the site and secured the replacement solar panel at the top. We moved the radio antenna to the new mast as well. We also made some changes to improve battery life. We replaced the deep-cycle battery in the instrumentation box with a spiral cell car battery which promises better performance in high temperatures. Furthermore, we installed a solar-powered exhaust fan on the instrumentation box in an effort to reduce the temperature during intense sunlight.

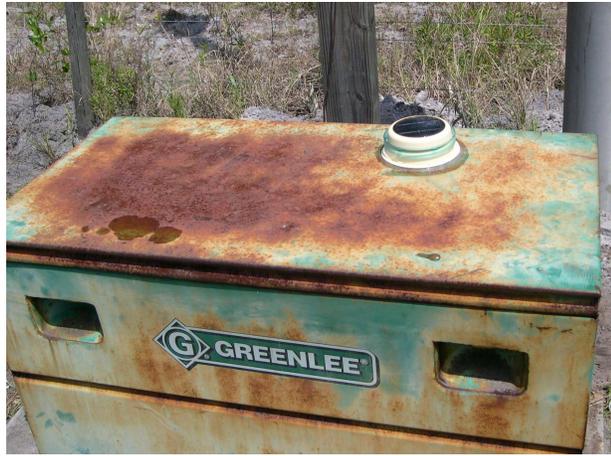
New exhaust fan on junction box

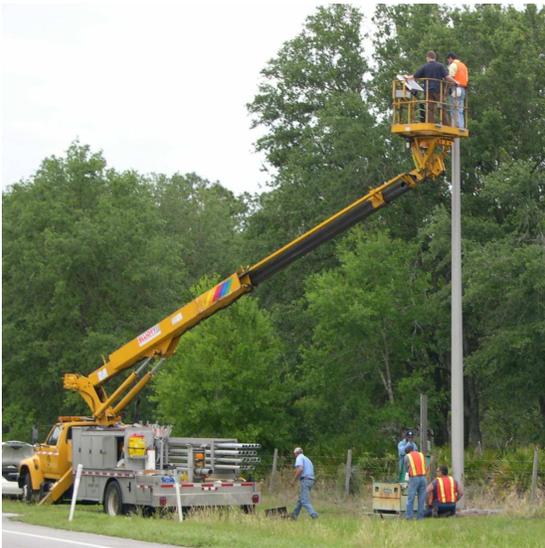
Installation of new solar panel on 30' mast

We recommend installing a second solar panel on the site. Remote monitoring of the battery voltage showed a steep decline in the five days after our visit, suggesting that the single replacement solar panel is not sufficient to charge the battery.

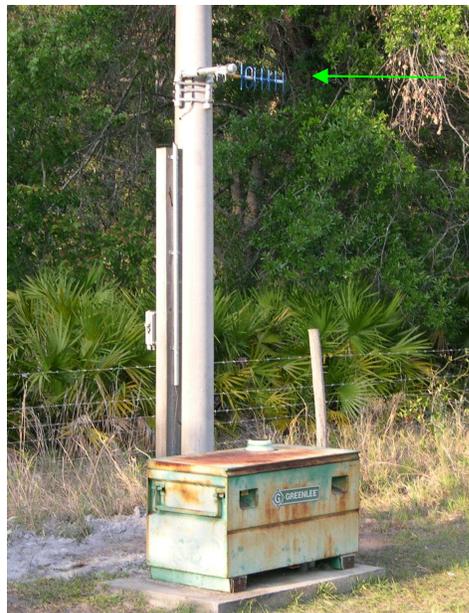
Antenna on new mast

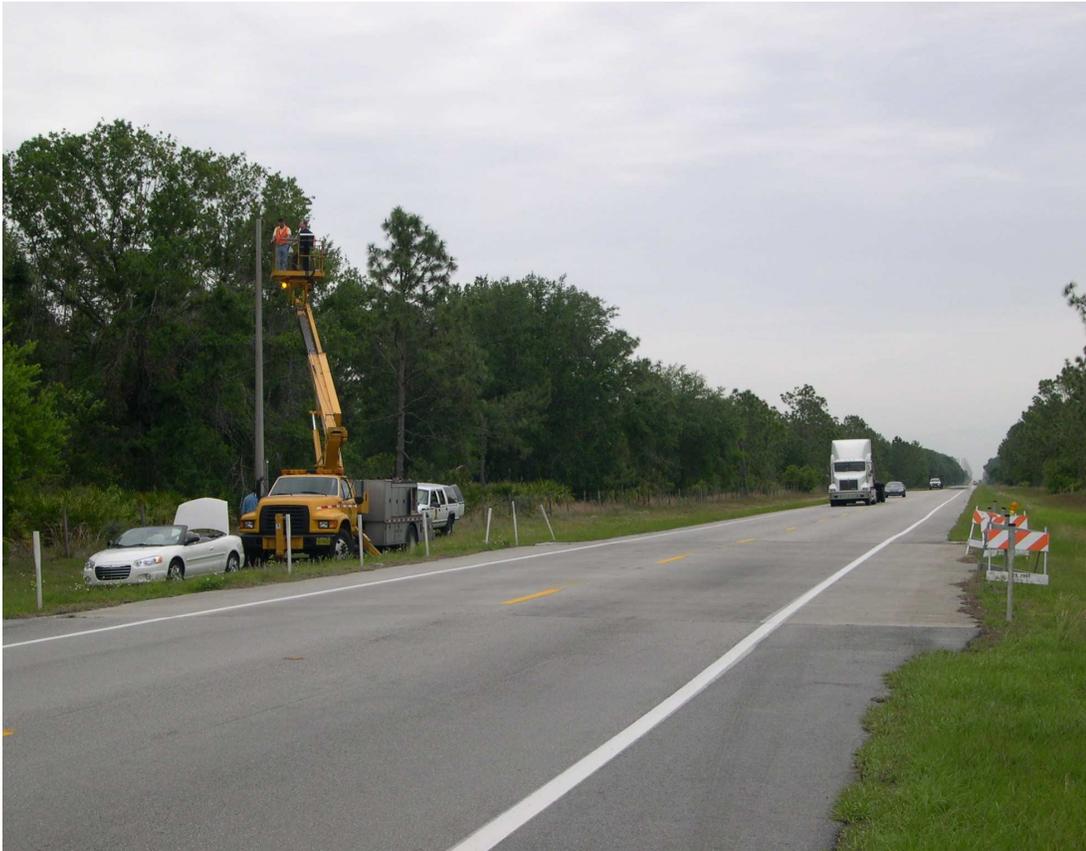
SR-66 Land Bridge, looking east (construction barricades mark washouts)

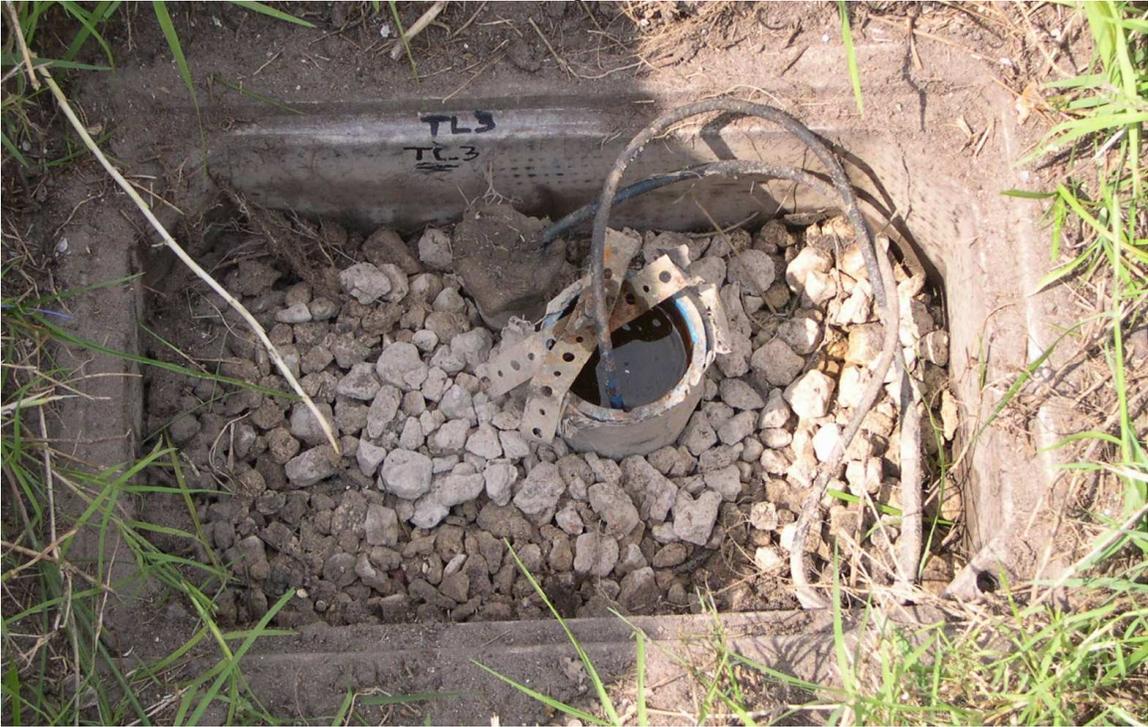
We extracted the tiltmeters that were suspected to be failed from their wells and tested them. Soil tiltmeters 2, 3, and 7 were found to be completely inoperative.

Soil Tiltmeter 3 in slotted inclinometer casing

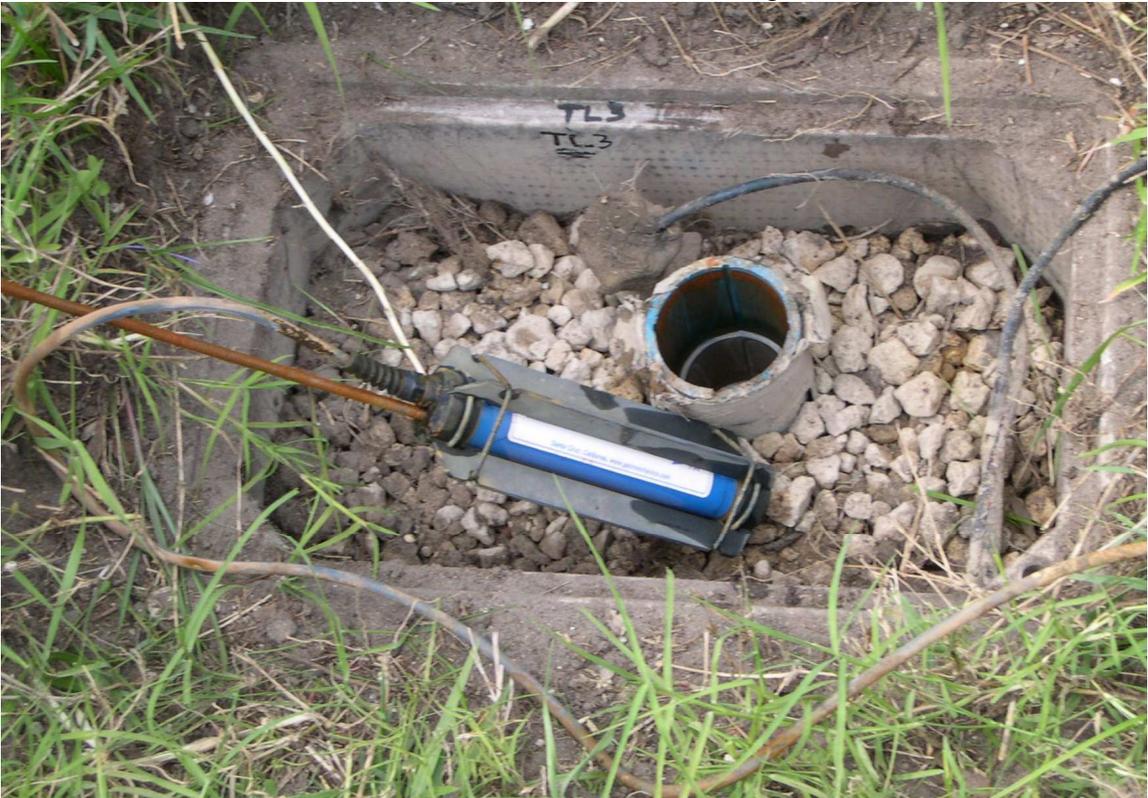
Soil Tiltmeter 3 removed from its slotted inclinometer casing

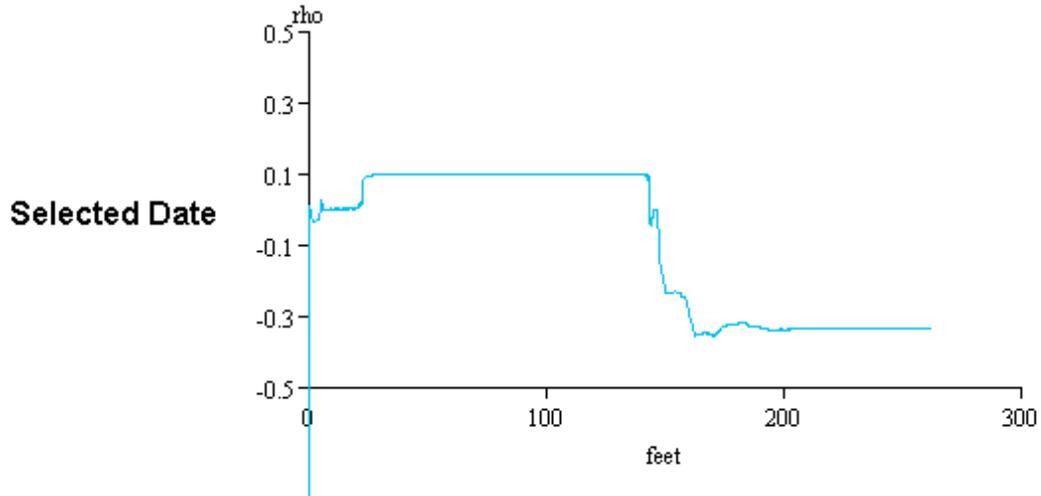
TDR 1

Remote TDR Waveforms with Repaving Damage
