2008-2009 REPORT

TEST HOUSE IN FRANKLIN, WI

ABSTRACT

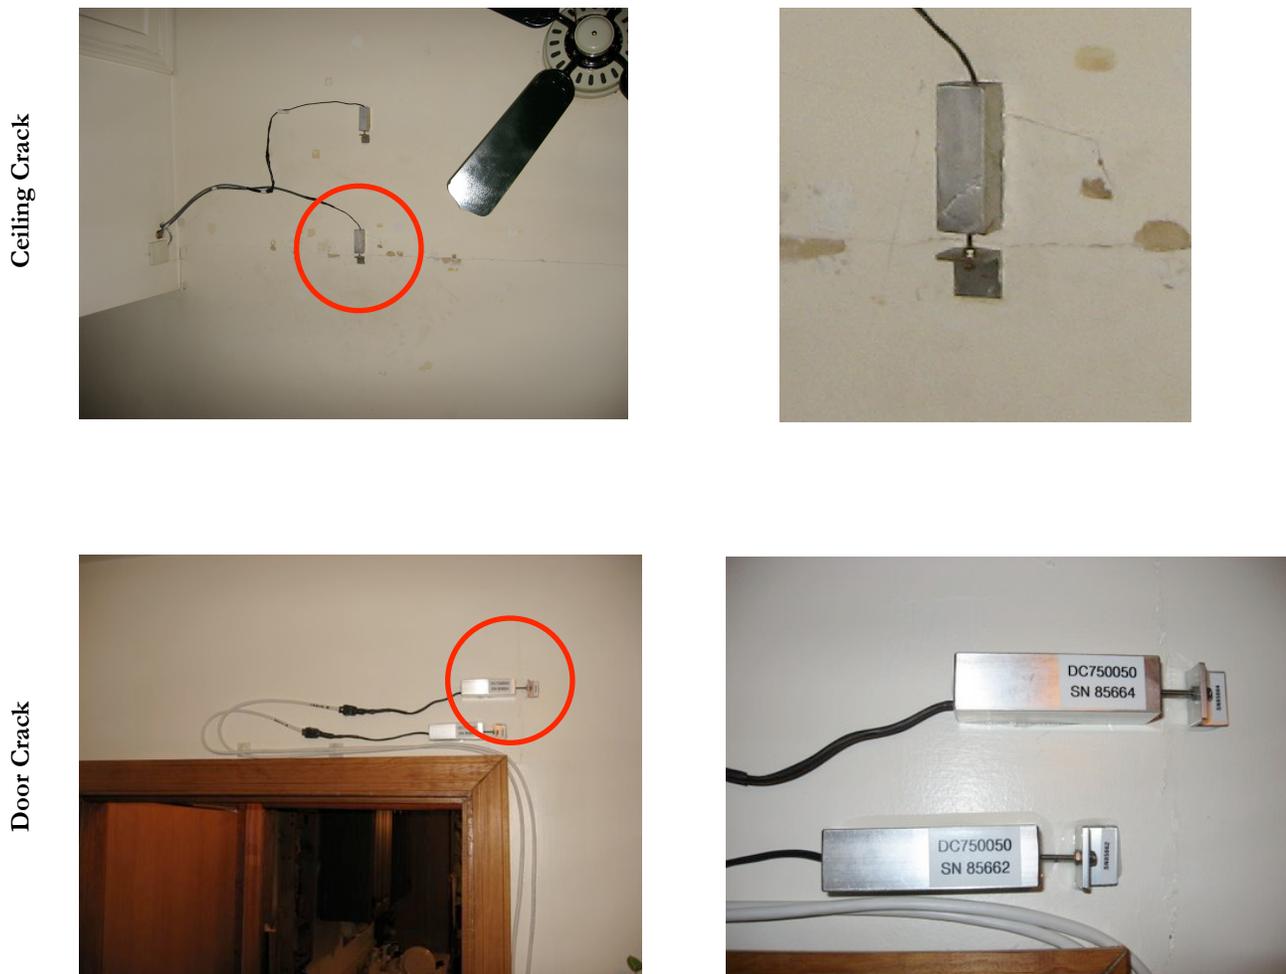
The test building is a one-story concrete masonry block structure, shown in Figure 1. The selected cracks have been present since ITI monitoring of the house began in 2000. McKenna notes that the cracks may be due to errors in construction or retrofitting of the structure: the room where the observed ceiling crack is located was created by knocking down a wall, and the door jambs are of unusual design. Cracks around door openings have been observed in several rooms in the building. (McKenna, 2002, pp. 102-103)

Figure 4 - Location of cracks monitored including context (left) and closeup (right). The ceiling crack appears on the top while the door crack appears on the bottom.

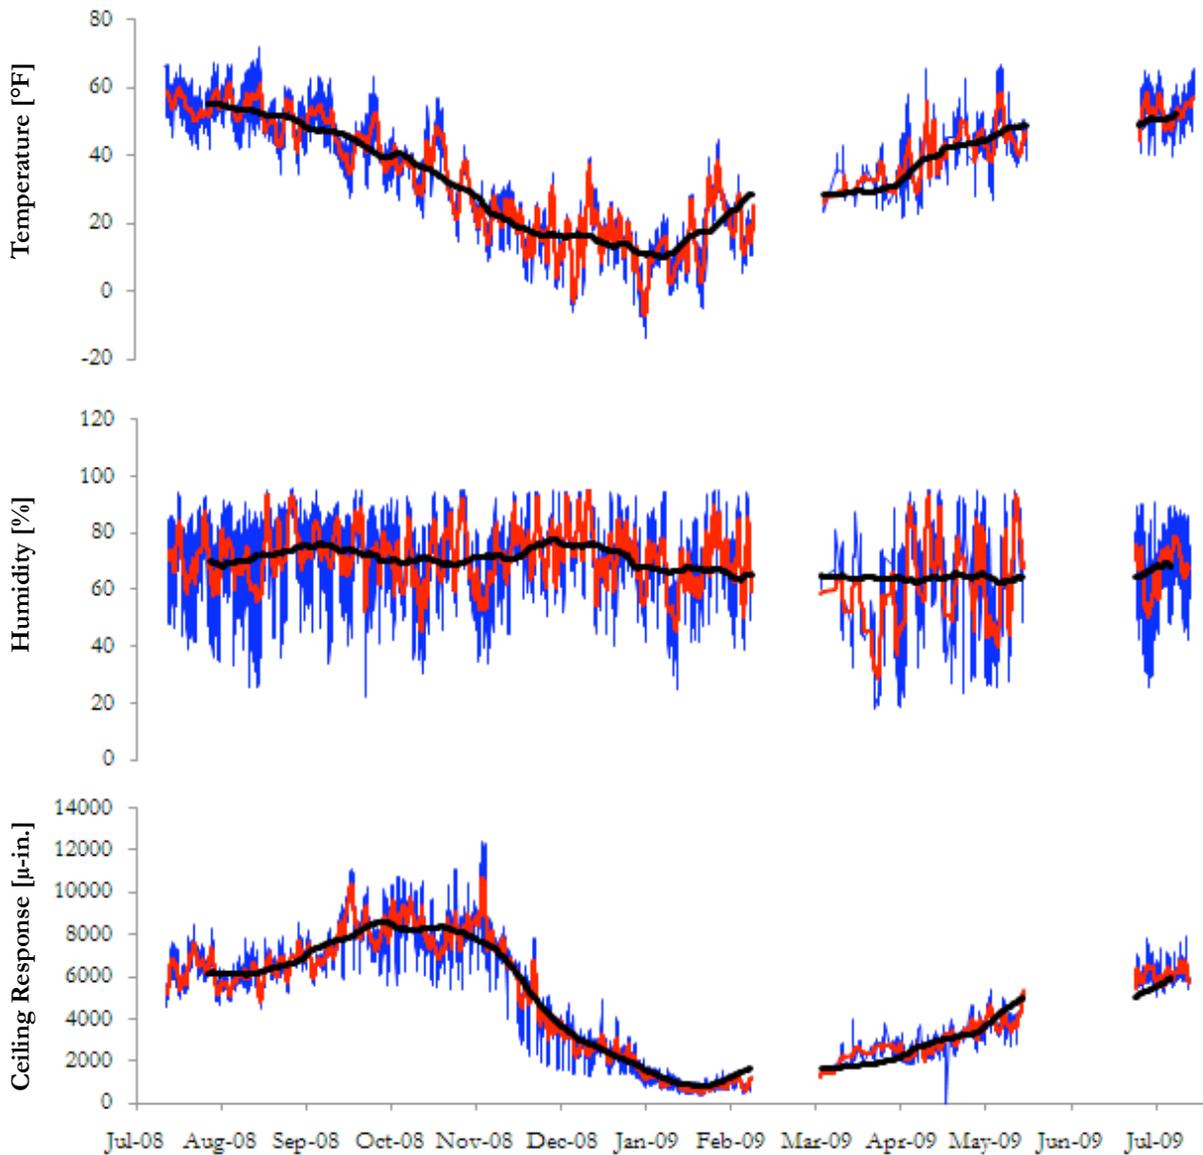
The crack sensors and outdoors temperature and humidity sensors were read every hour, registering a total of 6503 data points during the observation period. The DAS experienced problems in February-March and May-June 2009, and data for these periods are unavailable. The results can be seen in Figure 6 where individual readings are plotted in blue, the 24-hour central moving average in red and the 30-day central moving average in black. This approach facilitates an analysis of crack displacement response to changes in the weather.

Figure 6 - Correlation of outdoor temperature and humidity with ceiling crack response over a 1-year period.

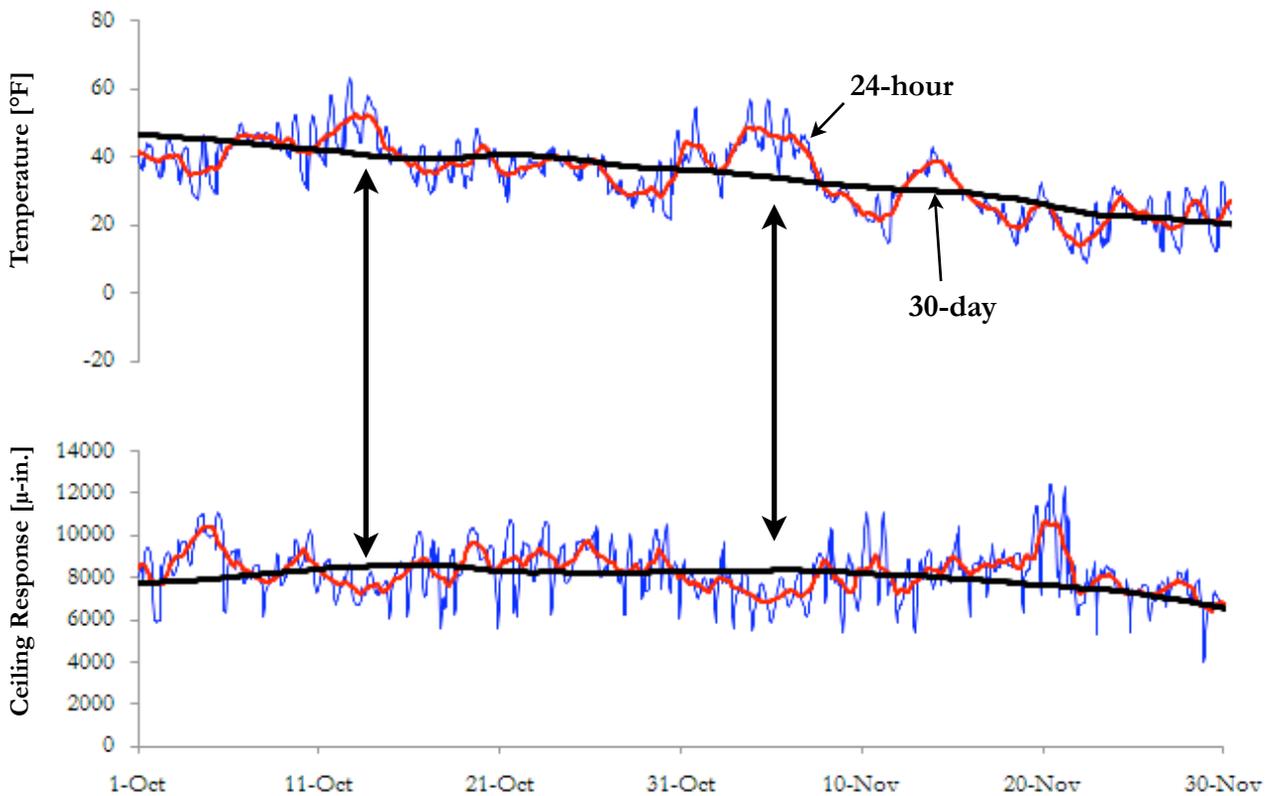
The same data plotted for a shorter period (October-November 2008) demonstrate that temperature variations correlate well with crack displacement. Since the red line is the 24-hour moving average and the black that for 30-day, the distance between them is indicative of the magnitude of change; a large, continuous change in temperature (indicative of the passage of a weather front) causes a deviation in crack response. The weather fronts near October 13 and November 5 (indicated by the arrows) resulted in substantial deviations from the 30-day average crack displacement. The largest deviation occurred around November 20th (3019 μ -in.).

Figure 7 - Correlation of Temperature and Ceiling Crack Response over a two-month period

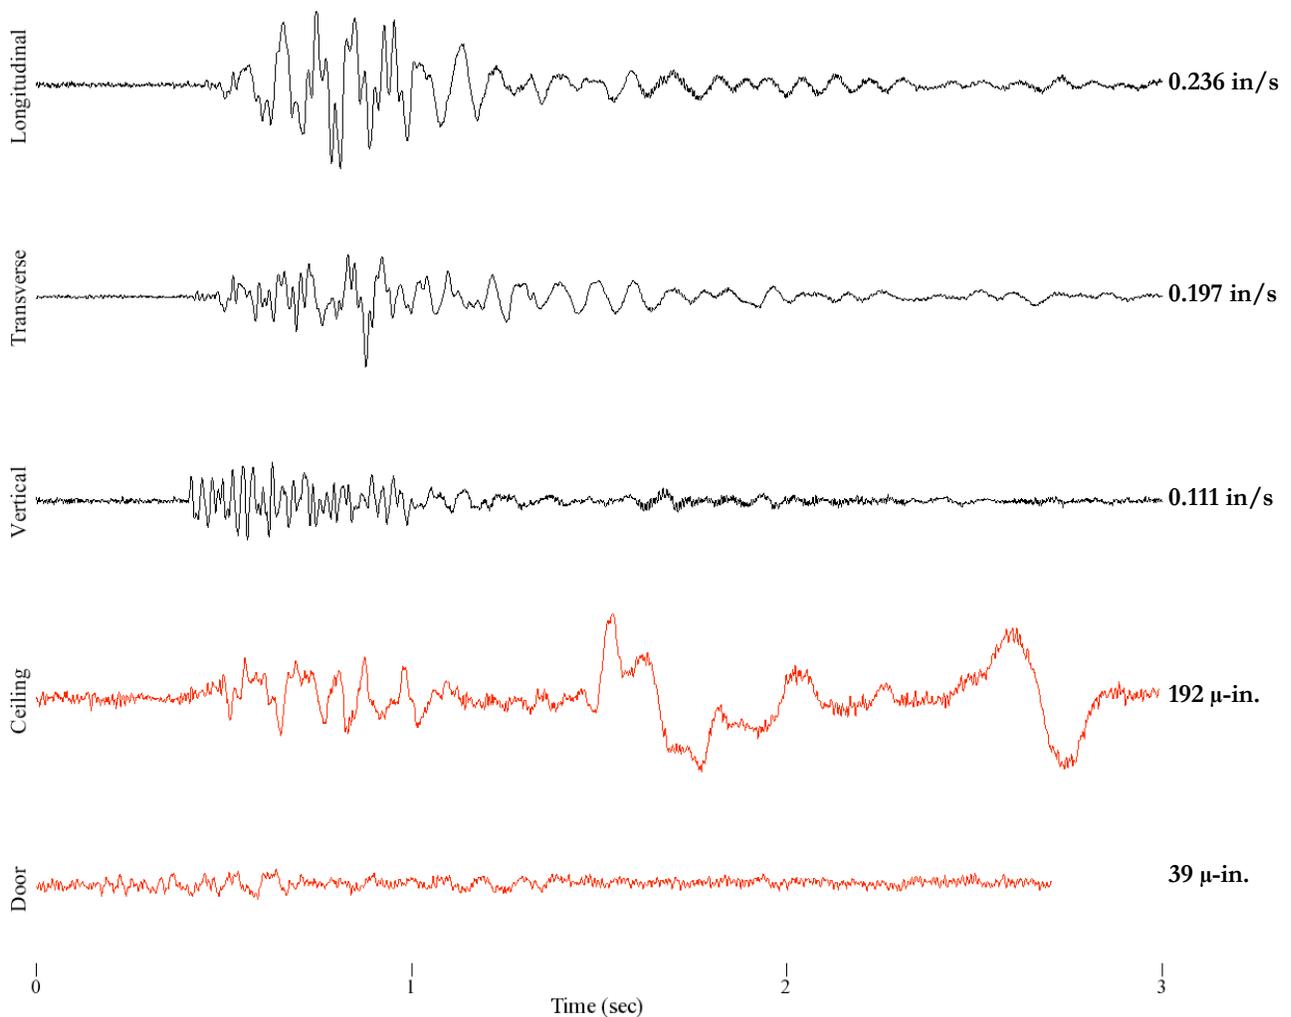
Crack response to 64 dynamic events are summarized in Table A in the Appendix. For each event, the peak ground motion in three orthogonal directions was recorded along with the crack response in microinches. The ceiling crack was monitored from the beginning of this project, while the door crack sensor was installed in March 2009. Figure 8 below compares the time histories of ground motion and crack response for an event on July 16th, 2009. The ceiling crack exhibits a zero-to-peak response of 192 μ -in while the door only responds 39 μ -in. Note that the ceiling crack responds significantly after the ground motion passes (to the air overpressure) while the door crack does not.

Figure 8 - Comparison of ground motion and crack response time histories for a blast on July 16th, 2009 at 10:45 AM

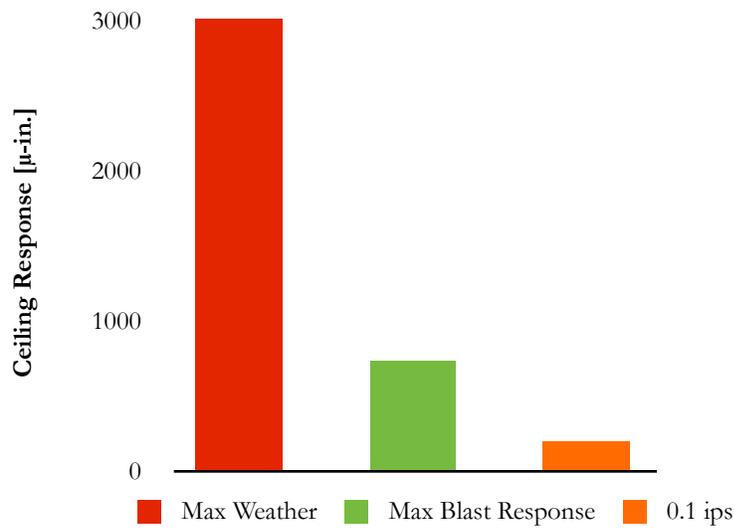
Figure 9 below compares the climatological response of the ceiling crack to its dynamic response. Response of the crack to weather fronts is 3x greater than the maximum response to blasting and 10x greater than response to ground motion at 0.1 ips. The ceiling crack often responds more to air overpressure than ground motion.

Figure 9 - Bar chart comparison of ceiling responses to weather fronts and blasting
