**REMOTE GLOBAL MONITORING OF THE
MICHIGAN STREET BRIDGE
STURGEON BAY, WISCONSIN**

**By David W. Prine and
Phillip E. Fish**

Technical Report #19

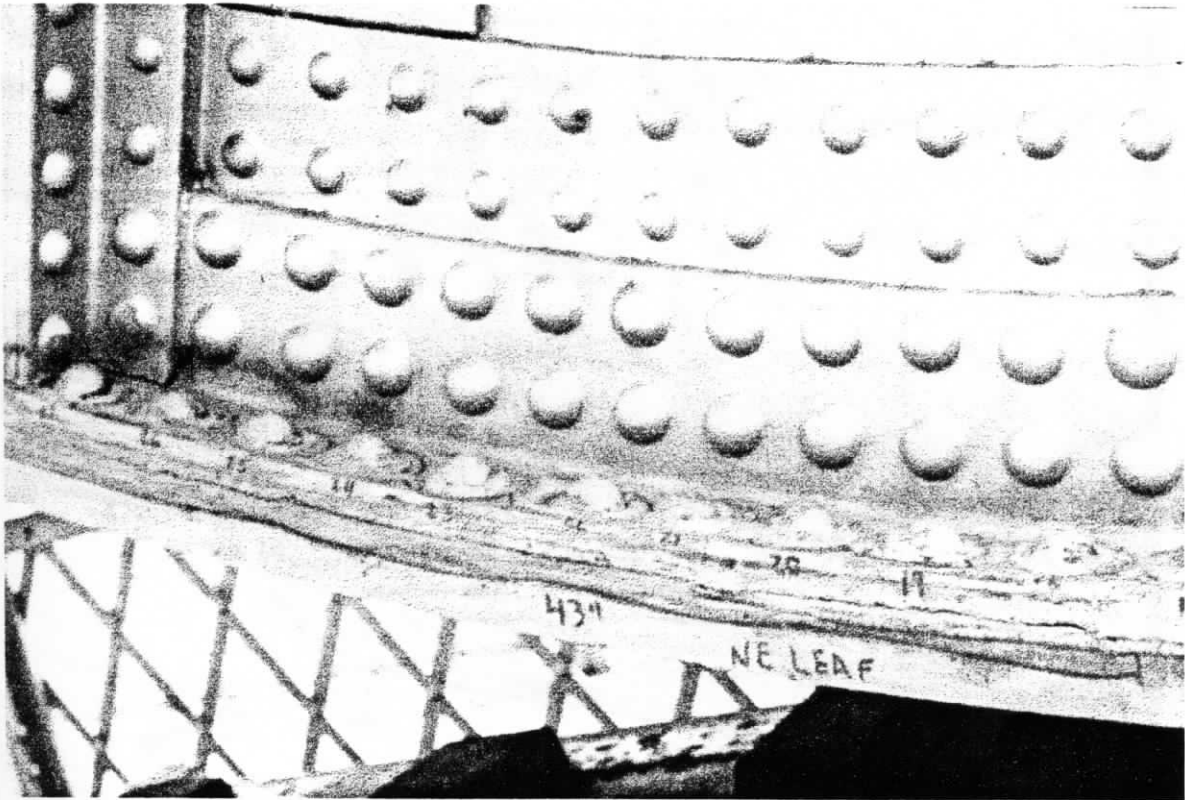
This inspection found serious cracking throughout the segmental girder. A majority of the cracks initiated from field repair welds that were placed in approximately 1965 although the date could never be clearly defined. Field welds were placed along the edge of the rolling plate and connection angles. Figure 3 below shows a view of this cracked field weld. Also, welds were placed around the rivet heads on the angles. Apparently this was done as an attempt to stop movement where the rolling plate was attached to the segmental girder.

The cracking was continuous along the rivet lines in the connection angles for several rivets. Cracks also migrated at random patterns from rivet heads. The connection angles

Figure 3 Cracked field weld.

Emergency repairs were performed by placing bolts in failed rivet locations. The bridge was load posted and placed on monthly inspection cycles the number of openings was reduced as much as possible.

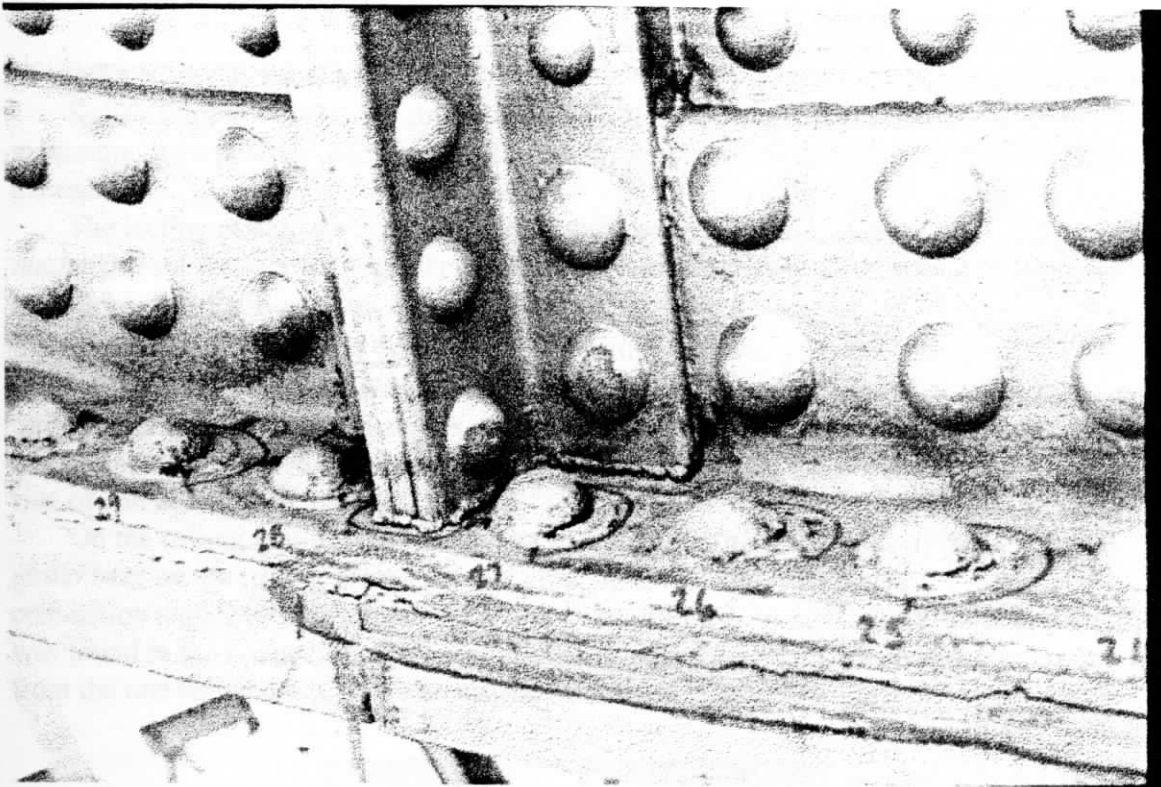
The field welds attaching the connection angles to the rolling plates were also cracked in many locations for several inches in length. Figure 4 shows one of the large cracks extending along the rivet line.

All rivets connecting the rolling plate to the connection angles were ultrasonically inspected and determined to be failed. The only holding mechanism for keeping the rolling plate in place at several locations was corrosion in the rivet holes.

Figure 4 - Large crack running along rivet line in segmental plate attachment.

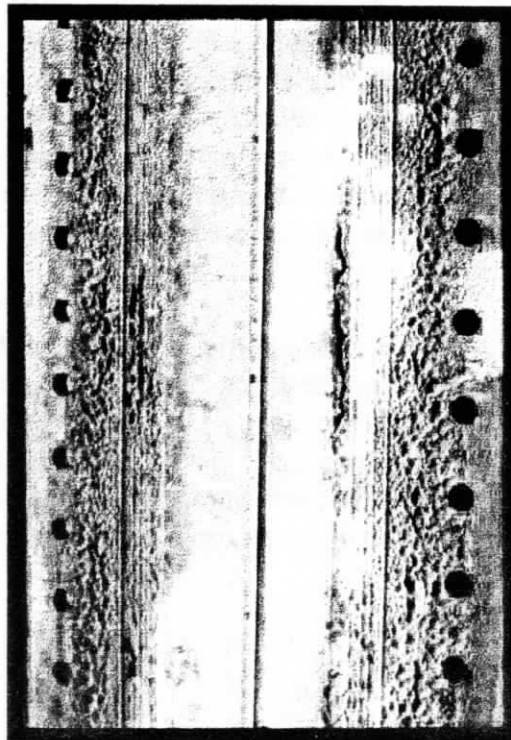
Unexpected conditions found Deterioration was more severe than expected. The cast steel track plates had considerable cracking on the bottom side. Where the cast steel track plates connected to the angles, there was heavy wear up to 1/8", and severe corrosion with deep pitting. Figure 5 shows the severe cracking observed on the back side of one of the track plates.

Figure 5 Showing severe cracking wear and corrosion on back side of track casting.

Cast steel track plates were taken to a fabrication shop and weld repaired under close supervision. Weld material and welding processes were selected that would be most compatible with the existing material. The process included restraints to minimize distortion, preheat, and post-heat to minimize cracking and internal stress. The cast steel track plates were cleaned to remove deep pitting corrosion and primed with paint.

Deterioration from wear and original casting flaws made it impossible to completely weld repair two cast steel track castings. Because of the fracture critical nature of these castings, we contacted Northwestern University's industrial research laboratory, BIRL and requested that they develop a strain gauging system to allow continuous monitoring of these plates from a remote location. Strain gauges were installed on the two plates while they were in the fabrication shop. The gauges were located between the two web plates of the box girder that is inaccessible when the cast steel track plates are in position on the bridge.

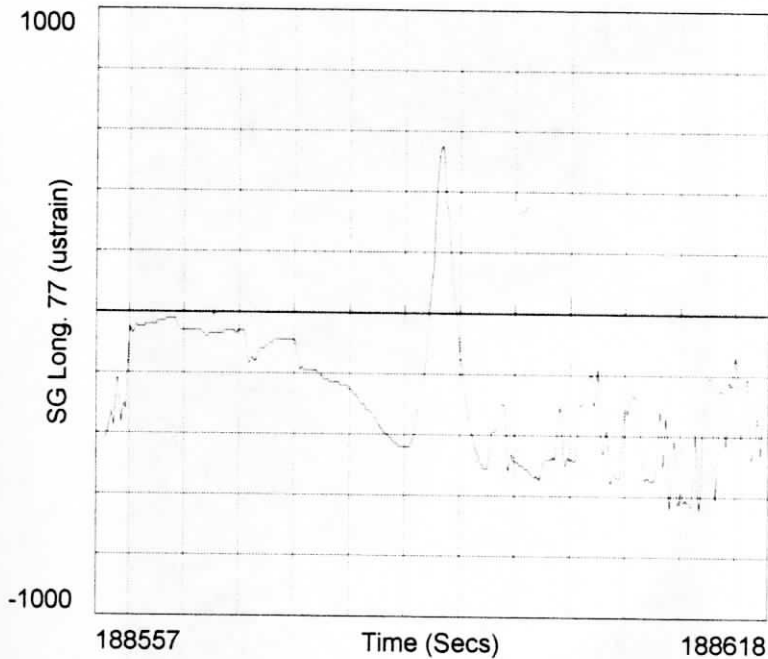
During the second week in August we began to observe radical changes in the data from the strain gage mounted at the most severely damaged site on the south west track casting. Initially, the departure from normal occurred in an isolated lift cycle and then returned to normal. However, after one additional day of normal operation, the abnormal readings increased in frequency. The abnormalities consisted of large amounts of drift in the strain gage zero and large discontinuous excursions of the strain readings during a cycle. Figure 12 below shows these phenomena..

We alerted the appropriate Wisconsin DOT personnel of these observations and expressed our opinion that they were probably related to progressive damage in the region of the strain gage in question. The large thermal drifts can be caused by crack propagation under the gage reducing the heat sink supplied by intimate contact between gage and casting surface. Similarly, the large discontinuous strain excursions could be caused by weakening of the casting in the damaged area resulting from crack propagation.

Figure 12 Abnormal strain reading

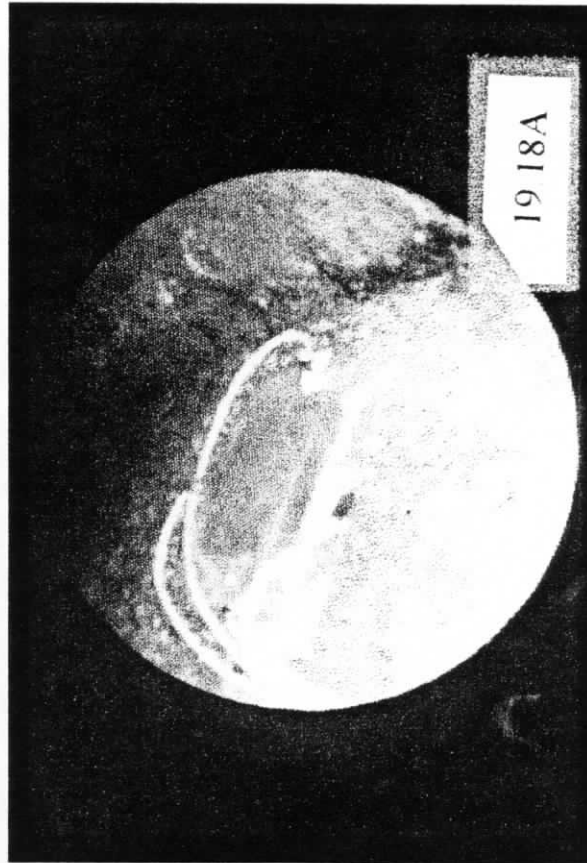
We met with Wisconsin DOT personnel at the bridge site and used a fiber optic boroscope to view the back of the casting in the vicinity of the strain gage that was producing the abnormal data. Access was gained through a check hole that had been drilled in a large surface crack. A photograph taken through the fiber scope is shown in Figure 13. Cracks are visible running into the strain gage cluster. These cracks were not present when the casting was repaired and are the probable cause of the abnormal strain gage readings.

Since these observations in mid August the damage continued to progress and successive gages were severed as the cracks propagated. The redundant gages that were originally installed in this area greatly extended our effective monitoring time for this damaged area. The final gage which was a longitudinal gage mounted farthest from the crack area severed in January of 1996 almost 5 months later. This incident demonstrated the effectiveness of this approach for remote global bridge monitoring.

Figure 13 Boroscope view of crack in back side of track casting
