**Crack Response of a Historic Structure to Weather Effects and
Construction Vibrations**

A Thesis

Field of Civil Engineering

December 2004

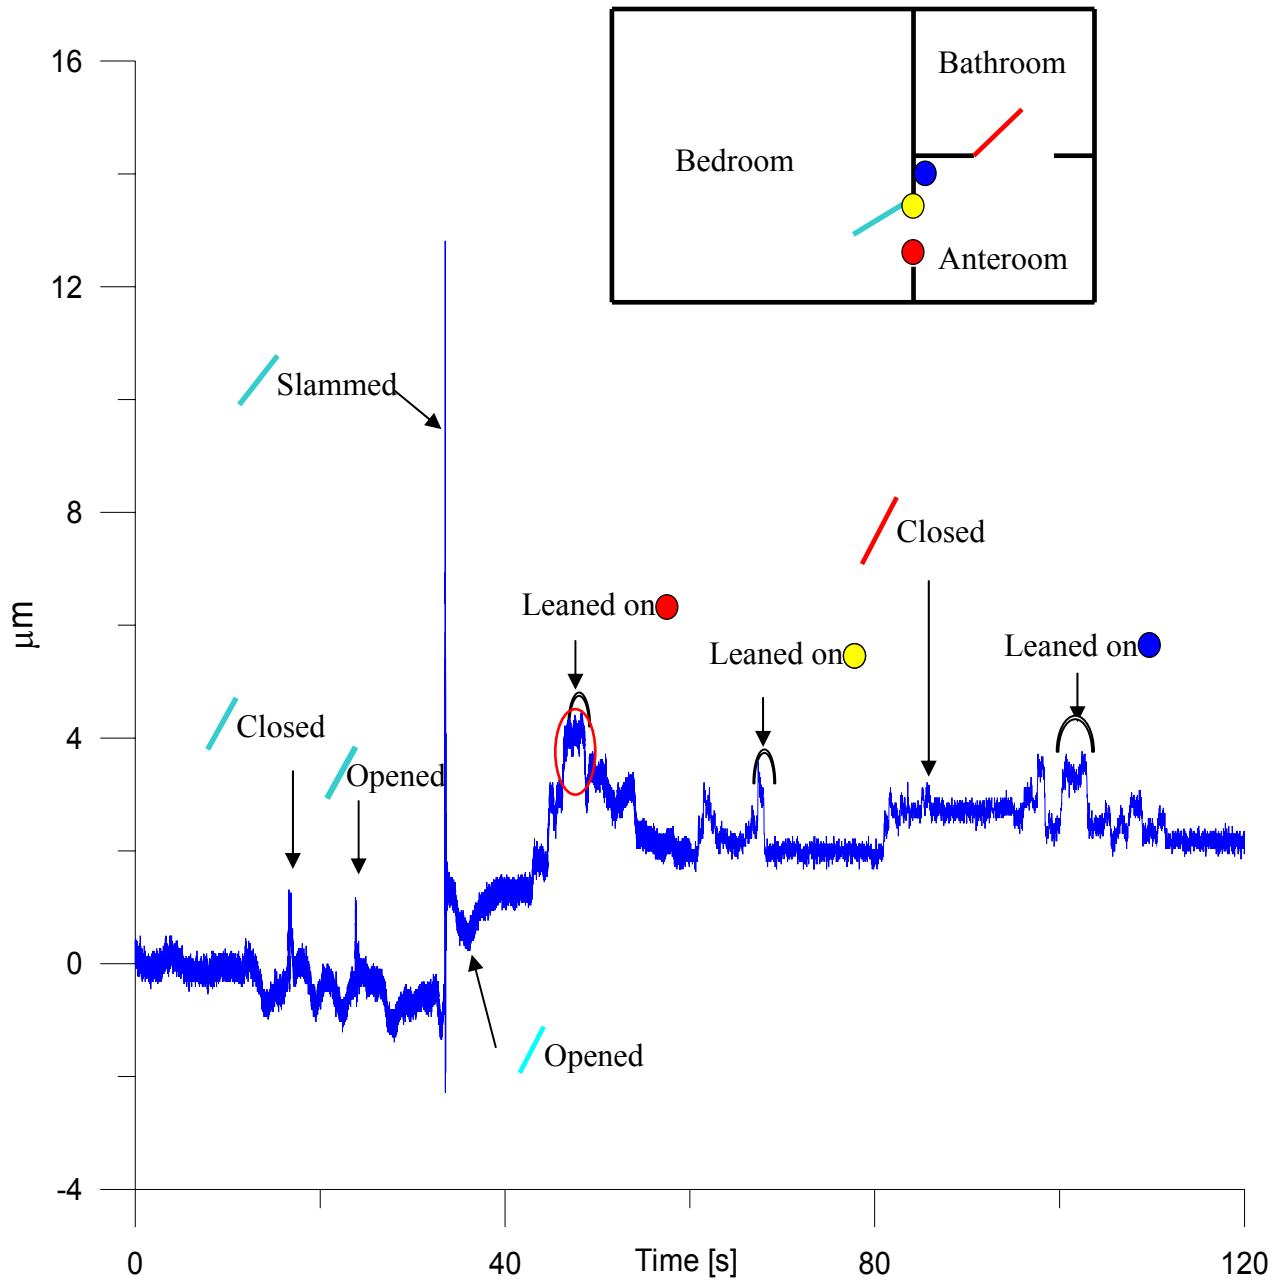
Figure 3-11: Time sequence of crack 3 displacement and occupant activity.

Figure 3-11 shows the two minute special study performed on crack 3. Crack 3 displacement is plotted with respect to time as in Figure 3-10. Rooms and door frame containing crack 3 are labeled on the plan view insert. Crack 3 responded instantaneously to human excitation by expanding and contracting, as did crack 2. Albeit the first

opening and closing of the bedroom door created relatively small displacement ($2\ \mu\text{m}$ or $80\ \mu\text{in}$), slamming the bathroom door induced the largest crack 3 displacement of $15\ \mu\text{m}$ ($600\ \mu\text{in}$). As will be discussed in Chapter 4, the responses to leaning are important because the same pattern was observed during a period of interior work, which occurred during jackhammer excitation.

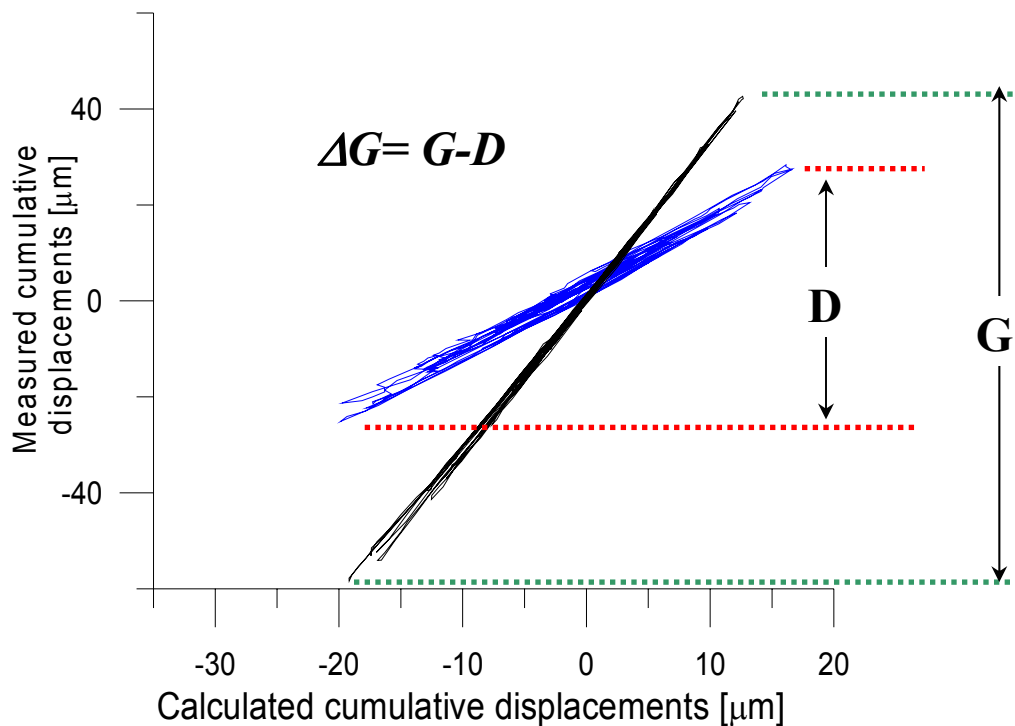
Figure A-10: The difference ΔG between plate and donut response

Even though plate displacement is larger than donut displacement this observation is not detrimental to the approach. In other words for a same material, the plate displacement exceeds the donut displacement with the same length of material between core and bracket. Suppose the LVDT reports crack (C) plus wall material and gauge (G) response to be C+G (=X). Then the real crack response would be X-G. But G is too large by ΔG (the difference between the plate (G) and donut responses (D)) as shown in Figure A-10), thus the corrected response would be X- (G- ΔG) which is X+ ΔG -G and greater than X-G. Thus the real crack change is greater than thought and the X-G value is conservative.
