Florida SR-66 Sinkhole Monitoring
April 2005 Field Trip Report

David E. Kosnik, EIT
Infrastructure Technology Institute
Northwestern University
Evanston, Illinois

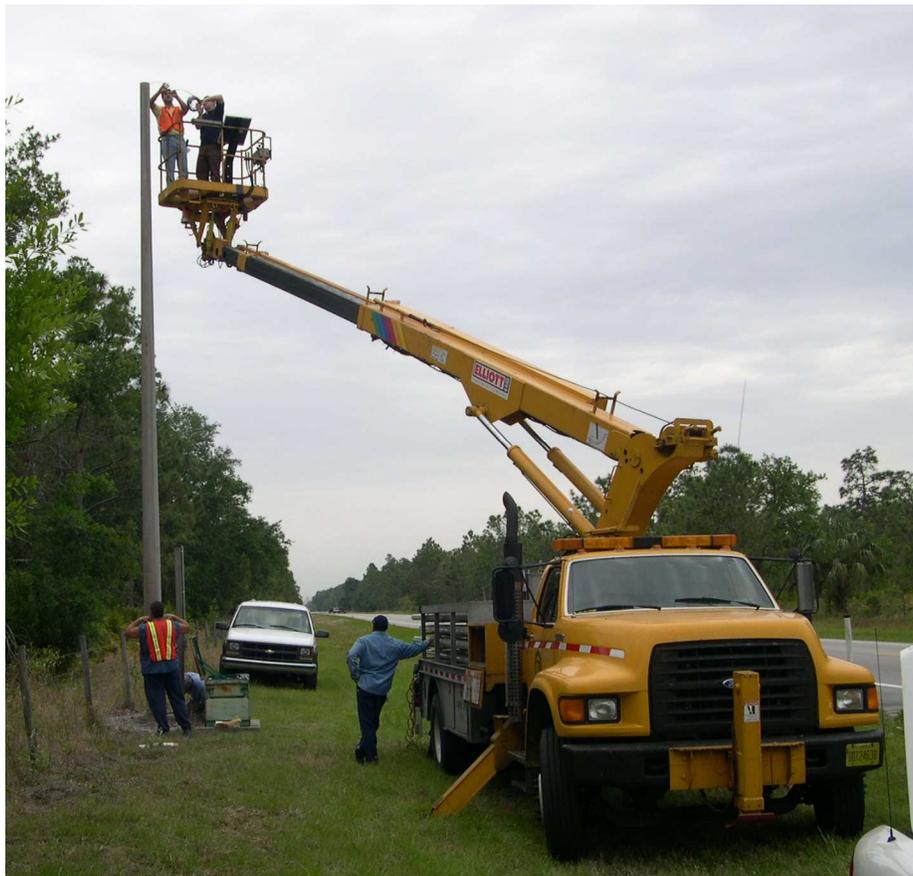
Soil Tiltmeter 3 in slotted inclinometer casing

We extracted the tiltmeters that were suspected to be failed from their wells and tested them. Soil tiltmeters 2, 3, and 7 were found to be completely inoperative.

As noted above, several sensors appear to have been damaged. Tiltmeters classified as “completely inoperative” showed no change in reading even when we extracted them from their casings and tested them with a voltmeter on the surface.

If FDOT wishes to restore this site to full working order, the inoperative tiltmeters will need to be replaced. In addition, a crew will need to replace the conduit and TDR cables under the road that were damaged during repaving.

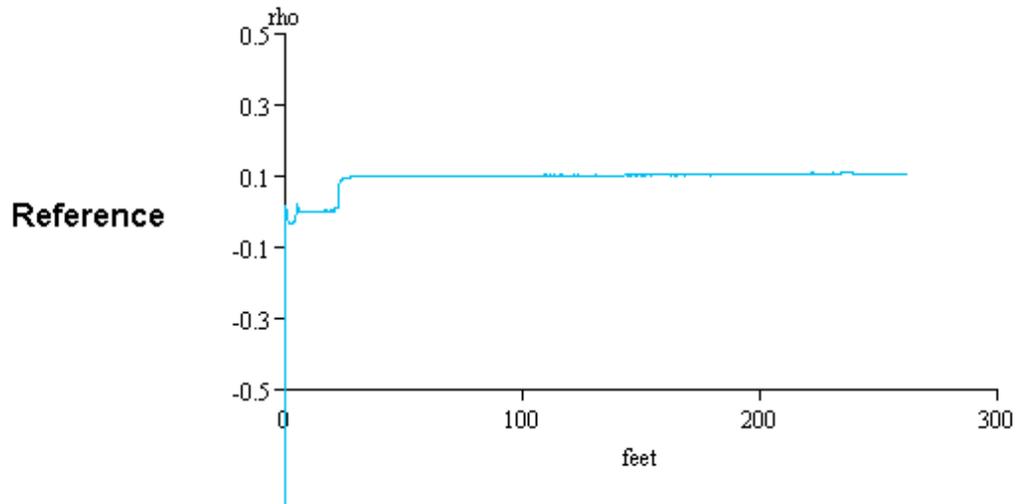
TDR 1

FDOT personnel pointed out that the road had been resurfaced recently, and that the resurfacing crew had been advised of the conduit crossing the road. However, we found a crack in the pavement suggesting that the conduit had been nicked or crushed during resurfacing. The location of the crack is consistent with the location of the kink in the TDR waveform.
