2008-2009 REPORT

TEST HOUSE IN FRANKLIN, WI

ABSTRACT

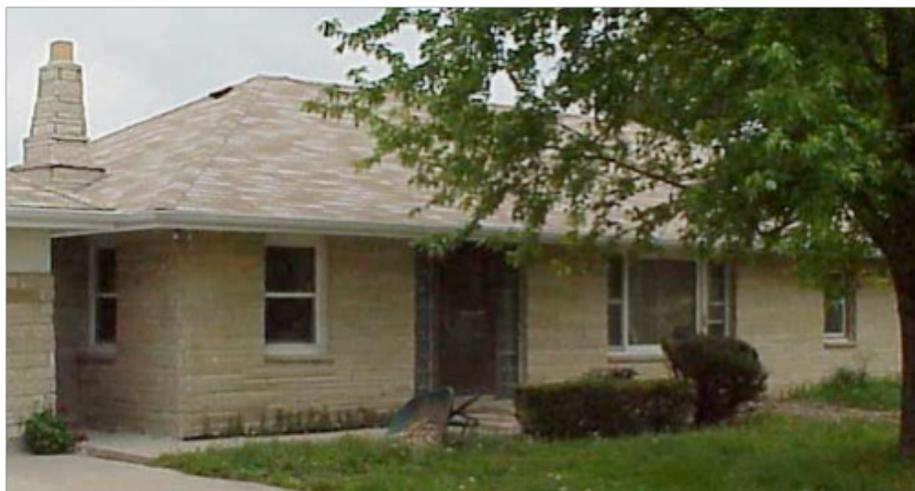
Figure 1 - Photograph of east face of house in Franklin, WI

The test building is a one-story concrete masonry block structure, shown in Figure 1. The selected cracks have been present since ITI monitoring of the house began in 2000. McKenna notes that the cracks may be due to errors in construction or retrofitting of the structure: the room where the observed ceiling crack is located was created by knocking down a wall, and the door jambs are of unusual design. Cracks around door openings have been observed in several rooms in the building. (McKenna, 2002, pp. 102-103)
