**REMOTE GLOBAL MONITORING OF THE
MICHIGAN STREET BRIDGE
STURGEON BAY, WISCONSIN**

**By David W. Prine and
Phillip E. Fish**

Technical Report #19

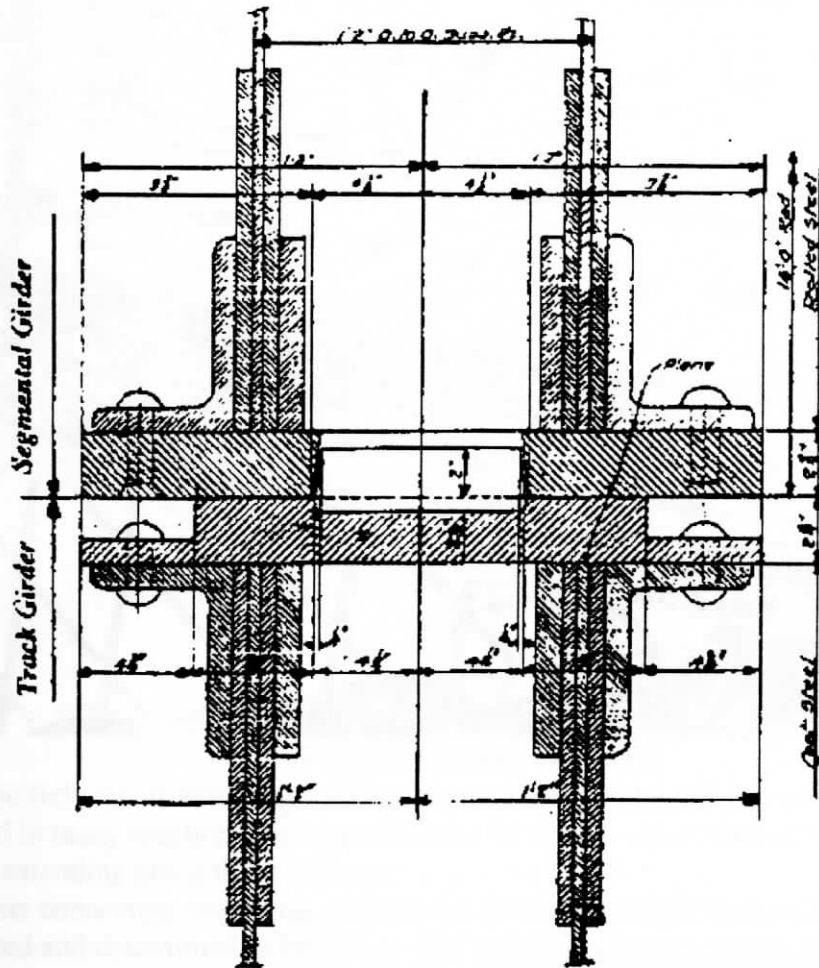
Figure 2 Track girder - segmental girder detail.

As shown in Figure 2, both the track girder and the segmental girder have two web plates spaced at 1'-2". A cast steel (A24 Material) track plate with teeth is attached to the top of the box girder with two single lines of rivets. This assembly acts as the track girder. The segmental girder has a rolled steel plate (A7 Material) with holes that match the teeth in the track plate. This assembly is also attached with two single lines of rivets. Structural material in the bascule girders is (A7 Material). All mechanical equipment to operate the bridge is located above the roadway along with the counterweights for each leaf.

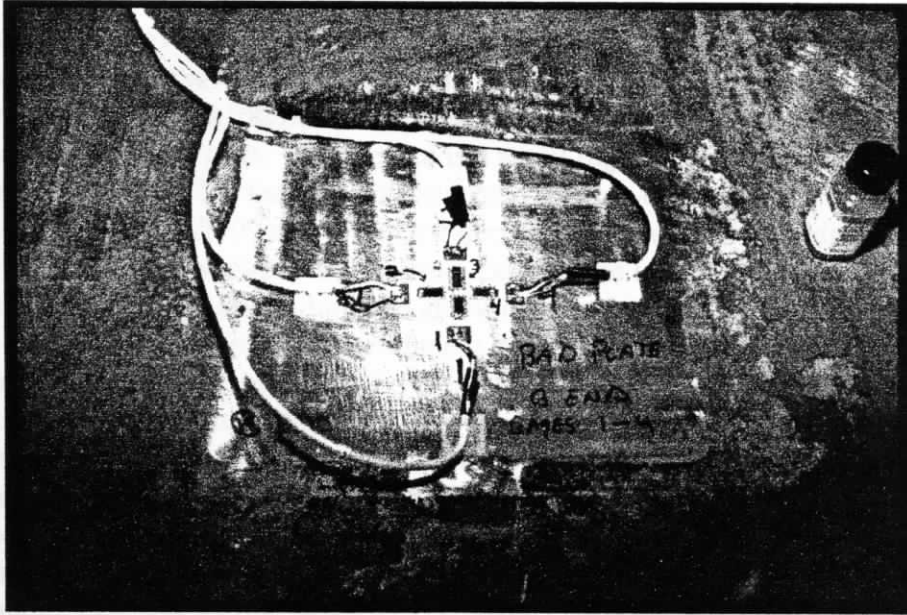
Figure 6 - Typical strain gage mounting pattern

A total of 16 weldable Measurements Corporation type CEA-06-W250A-350 strain gages were mounted on the two most badly deteriorated track plates. The plates were the first segments on the south east and south west quadrants of the bridge. The gages were mounted in quad groups with two gages in the longitudinal (rolling) direction and two gages mounted transverse to the plates long axis. This pattern was reproduced in two areas on each of the two castings. A close up of a typical gage mounting pattern is shown in Figure 6.

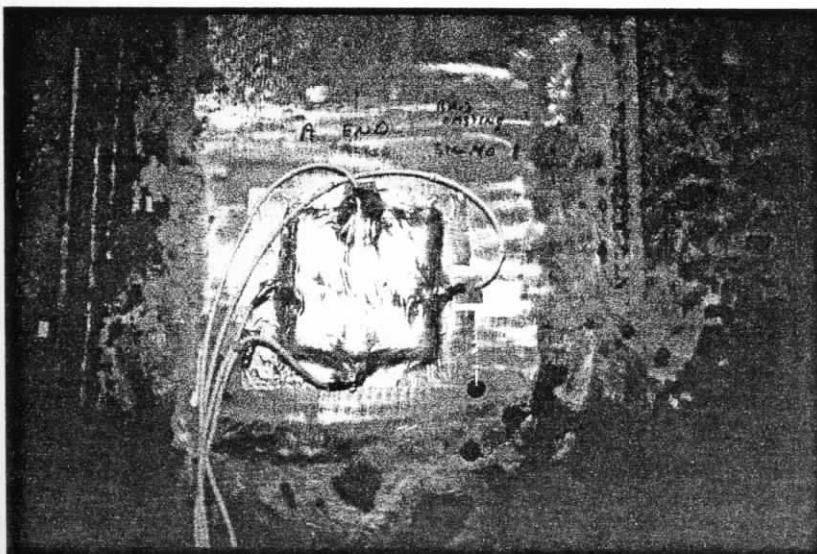
Figure 7 Gages with protective coating in place.

The placement of the gages was governed by two requirements. The first was to monitor strains in the most severely damaged areas during lift cycles and secondly to monitor strains in the bearing areas resulting from live traffic loading. One transverse and one longitudinal gage was needed in each area to monitor both components of strain. We decided to add additional redundant pairs in each of the four monitored areas to allow for potential gage failure over the projected 6 to 7 years of life for the rehabilitated structure. As we shall see in later discussions, this was a fortuitous decision. The gages were protected with Measurements "M" coat "F" system which is their most durable system. This system uses multiple layers of protective tape and neoprene rubber with specially formulated adhesives. A photograph of the protected gages is shown in Figure 7.

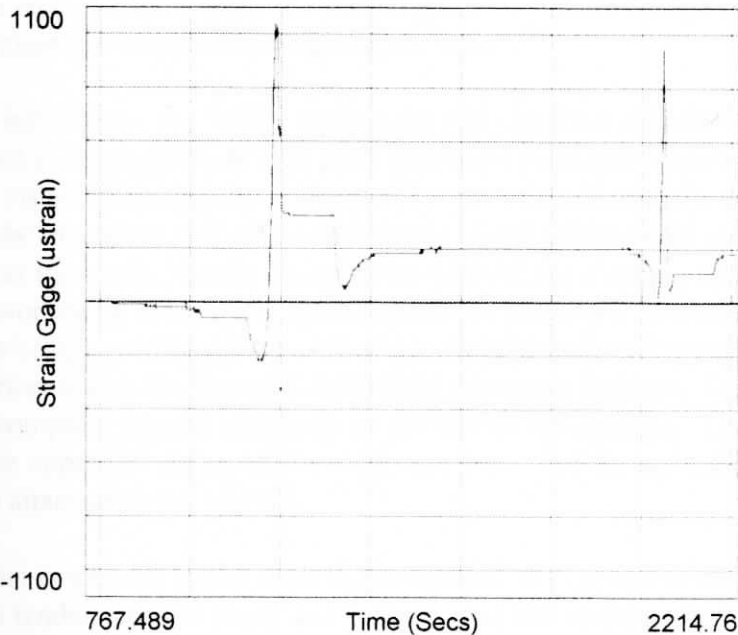
Figure 8 Strain readings from longitudinal gage at 77-inches, south west track casting #1

The initial closing cycle of each bascule leaf was monitored closely for any areas of interference. During these tests, longitudinal and transverse strain gages were also monitored. A Somat S-2100 field computer was used to monitor and record the strain gage readings for these tests. This device is a small rugged data logger approximately the size of a 3" by 5" card file that can be connected to a lap-top computer. The lap-top is used to initialize the S-2100 and set up the desired test as well as providing real-time display capabilities. The S-2100, if desired, can then be left in place on the test site to record test data for later up-loading and analysis. For the initial tests, the S-2100 was used in both real-time display and permanent data recording modes. Very high strains were observed in the severely damaged area of the west #1 casting. A plot of the first two cycles for the longitudinal gage is shown in Figure 8. The first peak was produced when the bridge rolled over the gage site for the first lowering cycle. The peak is over 1000 μ strain and shows a permanent offset of 200 μ strain following the first cycle. This response is indicative of possible damage and permanent distortion of the casting. The other gages did not show either the high initial reading or the permanent offset. Furthermore, this gage settled down to a consistent pattern after the initial closing. A plot of a subsequent lift cycle is shown in Figure 9. Prior to recording this plot, the gages were re-zeroed. The offset is no longer observed and the peak strain has reduced to 760 μ strain. Additionally, during these tests some movement of the main piers was felt when the bridge was raised to its maximum height. As a result of this observation, we decided to install clinometers on each of the two main piers. The clinometers were installed in

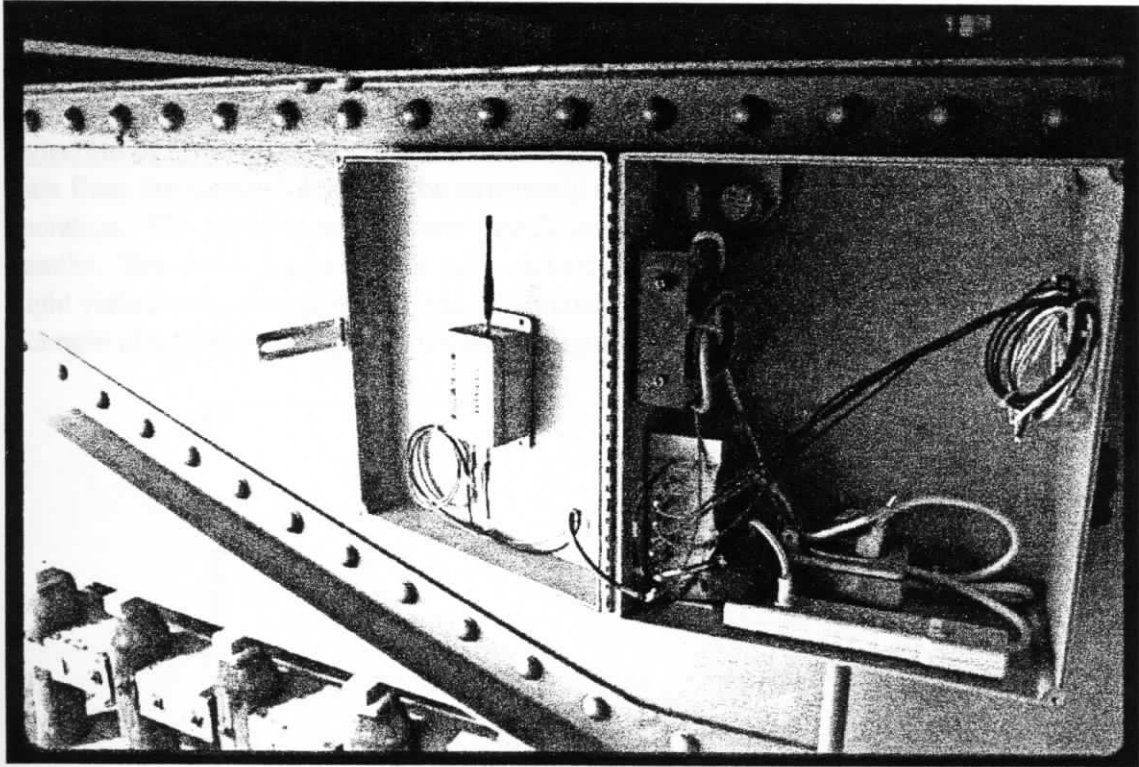
Figure 10 Remote field computer, clinometers and RF link mounted in protective enclosure.

Following these initial tests, the Somat equipment was installed in permanent protective enclosures located in areas on the bridge piers that were protected from view by casual passers by. The installed sensors are connected by short cables routed through water-tight conduit to the fiberglass protective enclosures. Each enclosure is mounted on the main pier cap near the track castings on opposite sides of the shipping channel. The two test sites are networked by means of a spread spectrum radio link to a host computer that is installed in the bridge tenders office. All of the signal conditioning and data logging functions are performed by the Somat S-2100 field computer systems. Figure 10 shows one of the field computer remote sites with its protective box opened. The clinometers can be seen in the upper left corner of the enclosure box. The spread spectrum radio link's antenna is attached to the box lid.

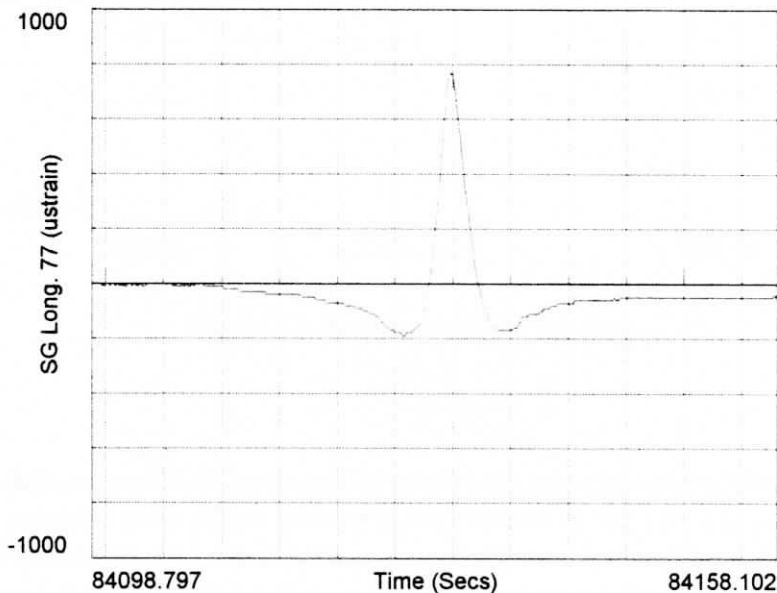
Figure 11 Typical data plot

Data from the sensors proved to be extremely consistent for the first few weeks of operation. The bridge averaged between 20 and 25 lift cycles per day during the summer months. The strain gage plots for successive cycles were nearly congruent except for slight variations in bridge speed which is manually controlled by the operator. An example of a typical data plot is shown in Figure 11.
