# **RESPONSE OF UNCRACKED DRYWALL JOINTS AND PANELS TO BLAST VIBRATION AND WEATHER**

**JEFFREY E. MEISSNER<sup>1</sup>**

**CHARLES H. DOWDING<sup>2</sup>**

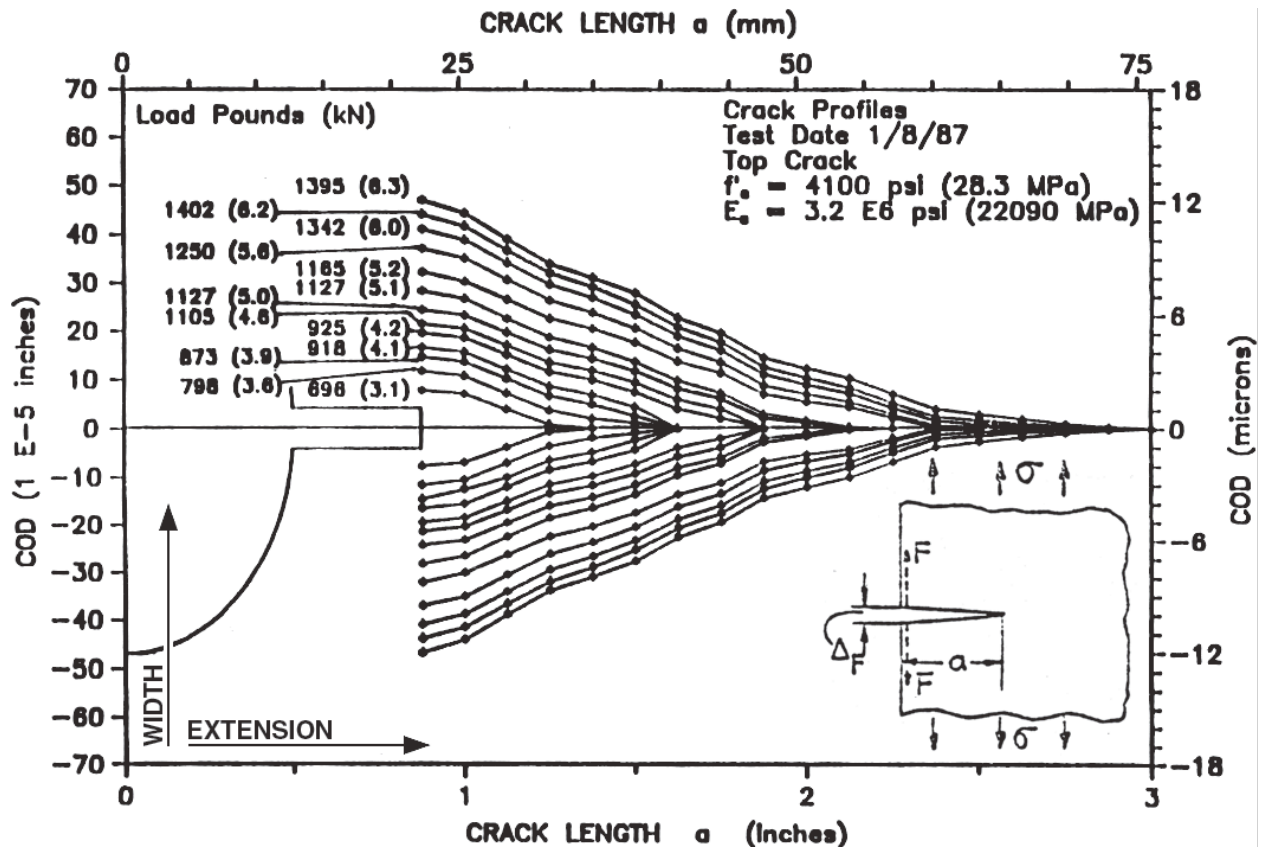
**Figure 1** -Experimental observation that cracks extend as their width increases forms the foundation of fracture mechanics as well as the ACM measurement approach. Special visualization techniques were employed to measure the extension of a crack (marked by the rightward extension of the ">") as its width (COD or "crack opening displacement") increases (marked by the increasing width of the mouth of the ">" on the left. (Miller, 1989).

Autonomous Crack Measurement (ACM) is based on measurement of micrometer changes in crack width, which is an index of the potential for the crack to extend. This logic is similar to splitting wood with a wedge. Hammering the wedge into the wood increases the width of the crack, extends the crack and eventually splits the wood. Thus comparing changes in crack width provides a comparison of the potential for crack extension. The wood splitting analogy is experimentally confirmed for fracture of cement paste as shown in Figure 1. Crack mouth opening (COD) on the vertical axis (similar to the action of the wedge to widen the penetration) is compared to fracture extension (length of the crack tip) on the horizontal axis. As the wedge width, COD, increases from 90 to 270 micro inches (2.25 to 6.75 micrometers), the crack extends from 1.4 to 2.1 inches. The graph itself displays both the opening and the extension as they increase in concert. Fracture extension by increasing crack mouth opening – crack width-- is the fracture mechanics foundation for the ACM approach.

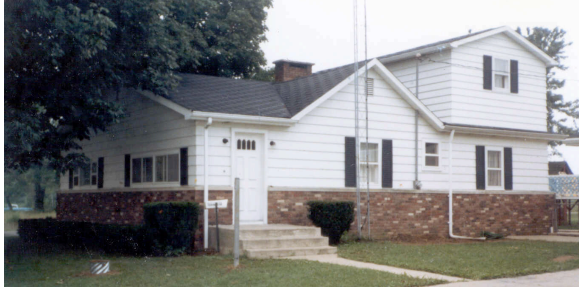
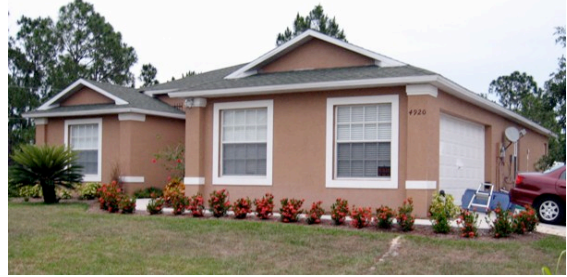
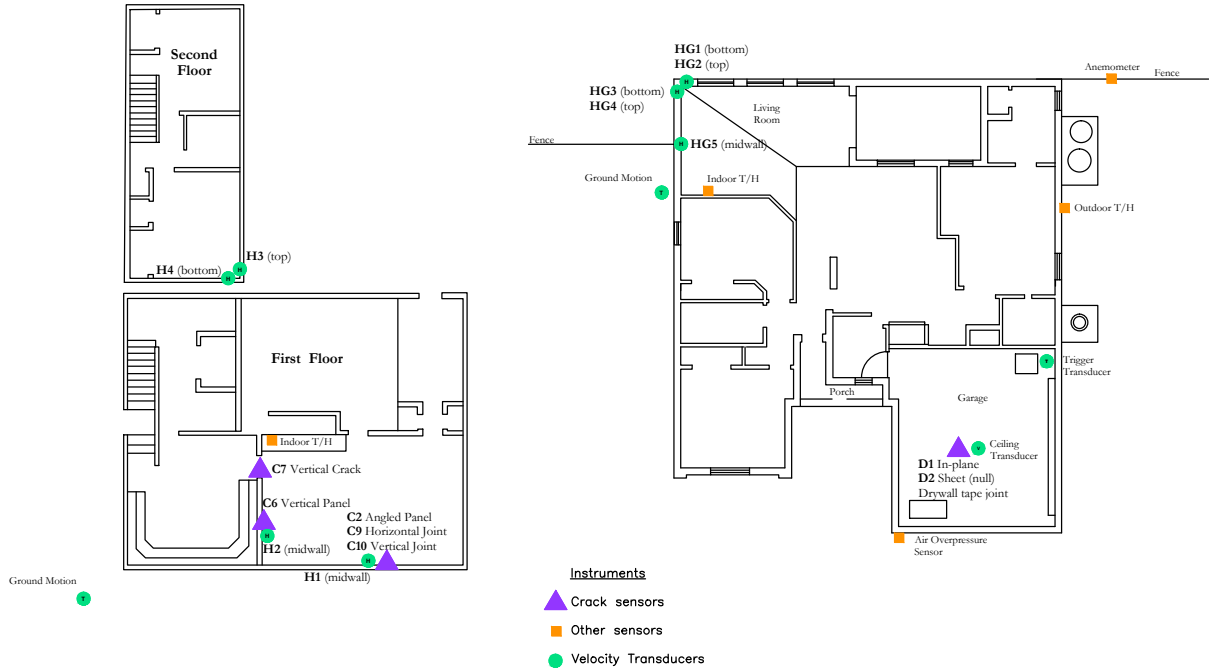
**Figure 2** - The two houses near Blanford, Indiana (left) and Naples, Florida (right) containing the un-cracked and cracked drywall joints crack instrumented in this study; top photographs; bottom plan views showing sensor locations

Measurements described herein were obtained in two houses whose photographs and floor plans are shown in Figure 2; one in Blanford, Indiana and the other near Naples, Florida. The Indiana house contains two, instrumented, un-cracked drywall joints and a cracked drywall joint for comparison. Its multiple sections shown in the photograph were built over a period of 10's years, with the middle the oldest and the right most, two-story section the newest. Each section is built on a basement, with a full basement under the two-story section, a shallow basement beneath the middle and a crawl space beneath the left (Dowding, 1996). The walls, interior and exterior are constructed of standard wood studs and were covered in drywall for the observations. The Florida house contains an instrumented drywall joint in the garage ceiling. It is a slab on grade structure, whose exterior covered walls are built with concrete masonry units (CMU), and interior walls and ceilings were constructed of wood studs and gypsum drywall (Kosnik, 2009).

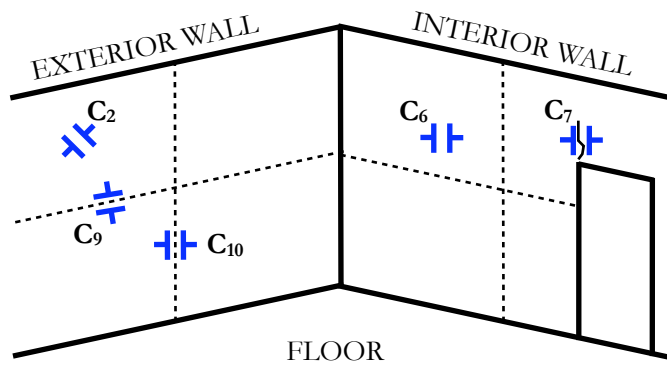
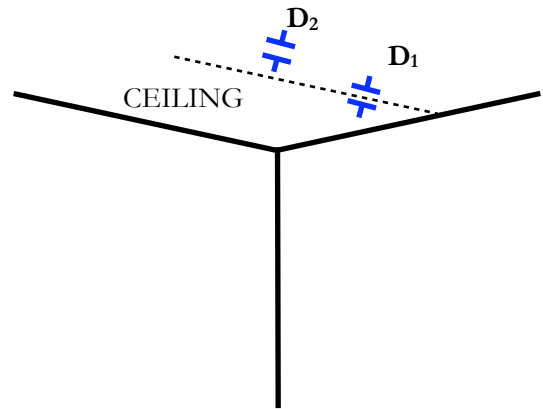
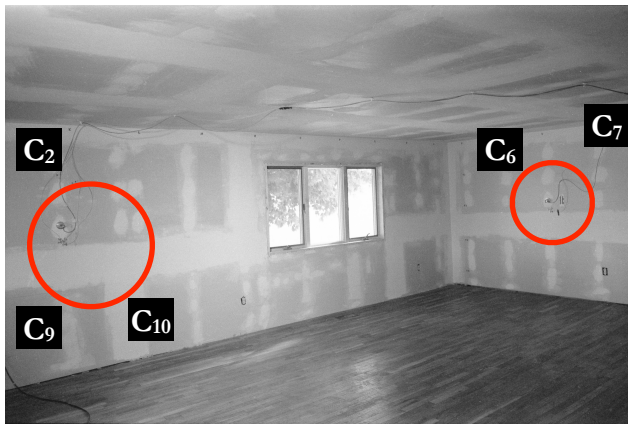
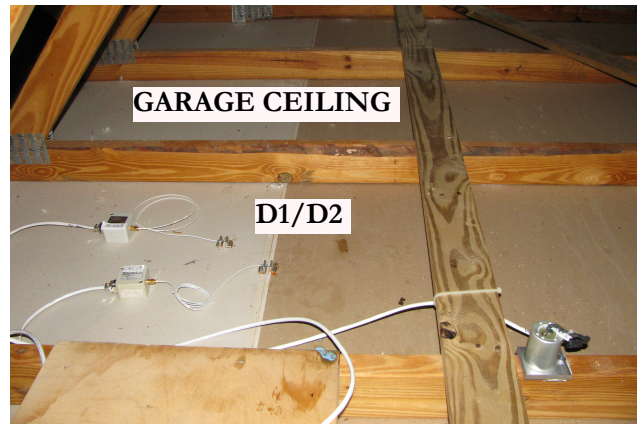
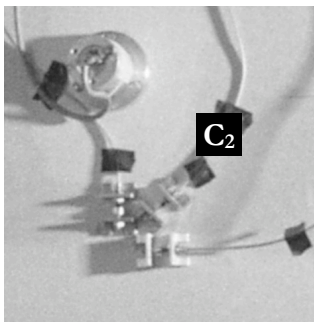
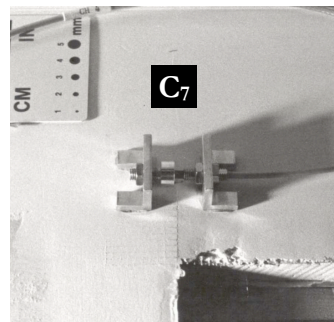
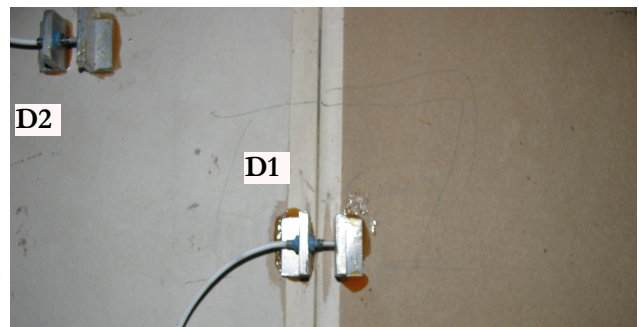
**Figure 3** - Installed details of drywall joints and sensors placed in the Indiana house (left) and Florida house (right). Wall, joint and sensor orientation are illustrated on the left. Photographs showing context are in the middle column and detail with detail on the right. C9&10&D1 across uncracked drywall joints; C7 across cracked drywall joint; and C2&6&D2 on drywall sheets.

Context (top) and details (bottom) of the installations is shown in Figure 3 with those for the Indiana house on the left. The living room walls in the Indiana house contain the instrumented dry wall joints as shown in the drawing and center photograph. Horizontal and vertical un-cracked dry wall joints are C9 and C10, un-cracked locations near the centers of the drywall sheets are C2 and C. Drywall joint crack is C7, which as shown in the right most photograph, is at a doorway (to the right of C6) between the living room and the kitchen (LR and K in Figure 2). This crack is not fully extended, and did not extend during the observation period. Similar information for the instrumented garage ceiling drywall joint is shown in the bottom row in Figure 3. Sensor D1 spans the joint and D2 is nearby on the full section drywall.

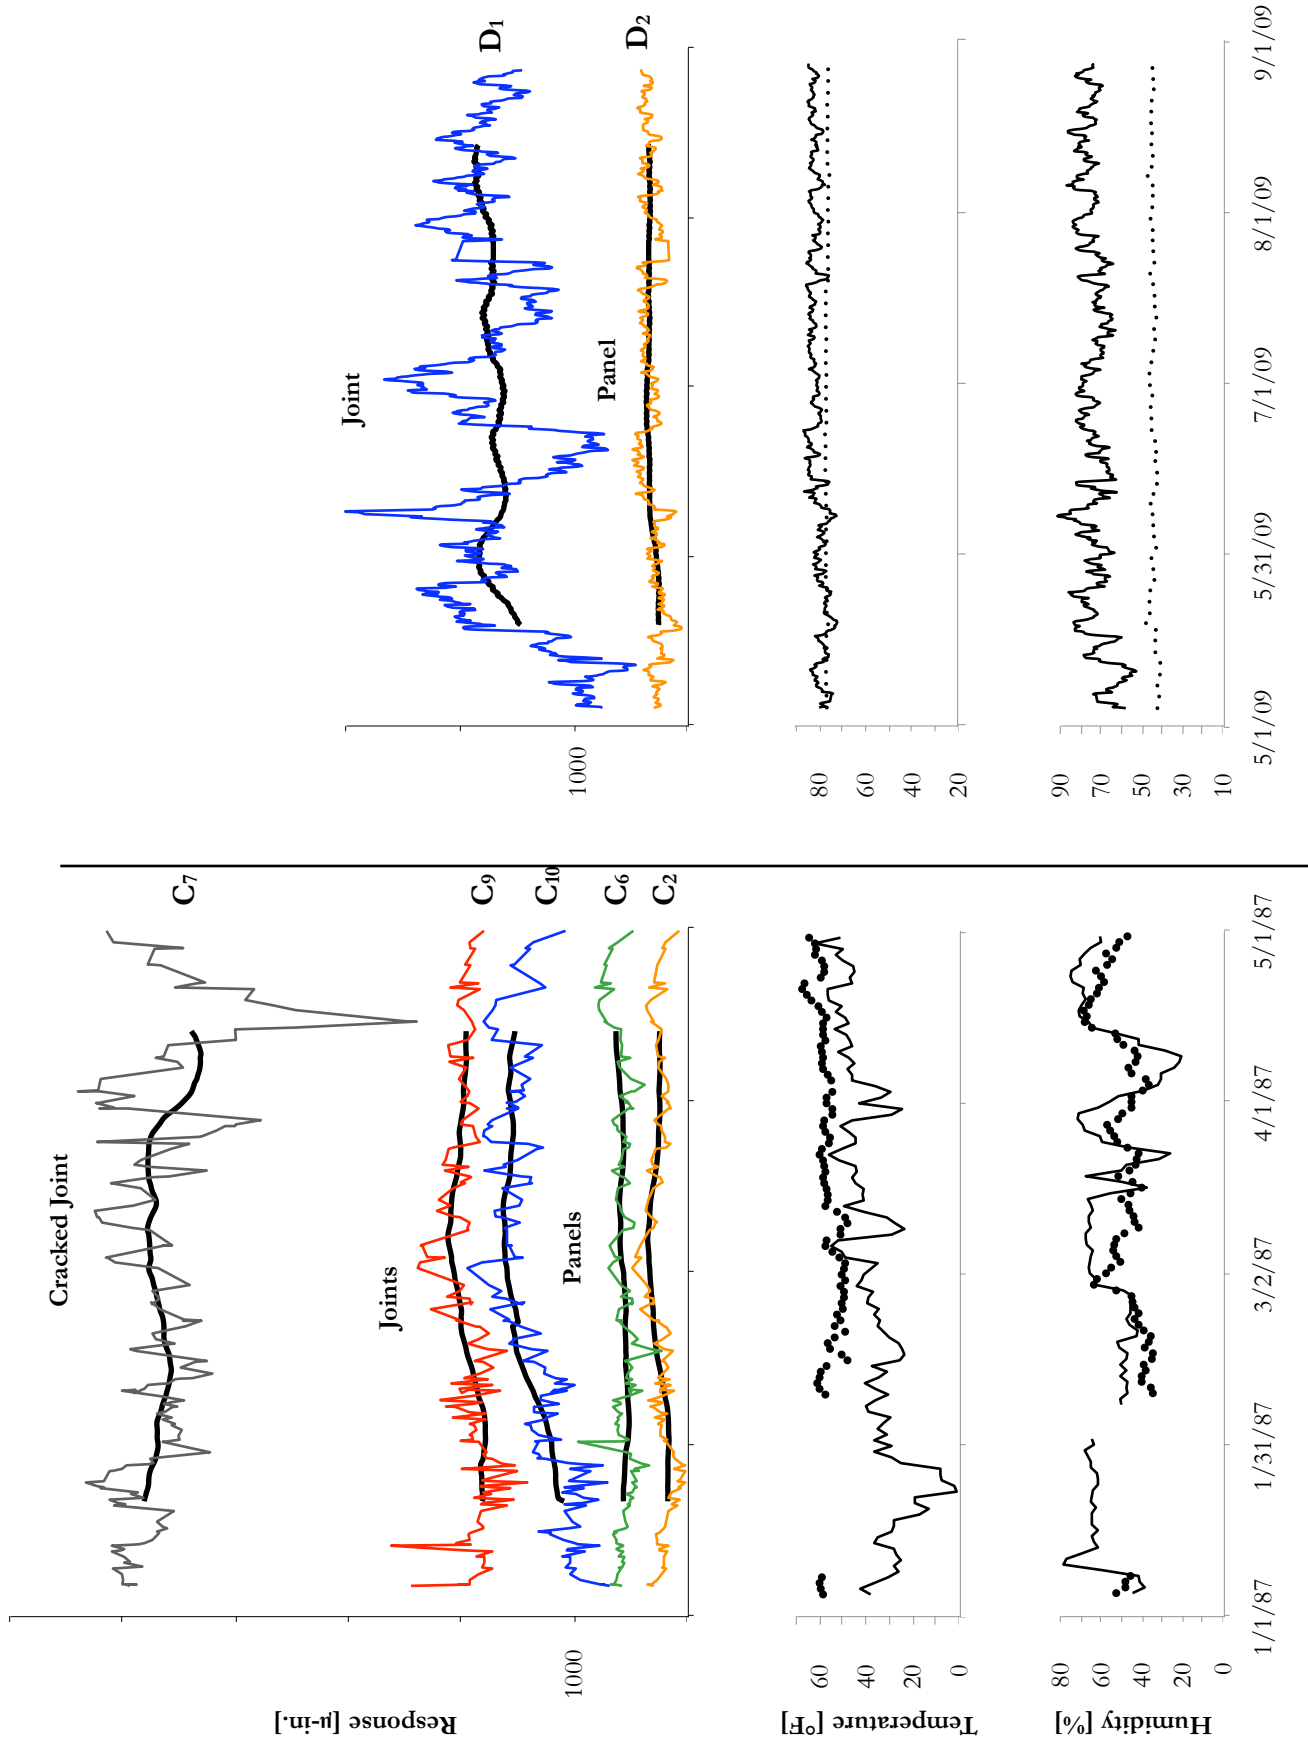
**Figure 4** - Comparison of four months of climatologically induced responses of Indiana (left) and Florida (right) joints. 30-day central moving average shown with a solid line. Temperature and Humidity (bottom, dotted=inside, solid=outside), and joint responses (top) are given with common time and response scales for comparison.

Figure 4 compares four months of responses of the 3 un-cracked (C9,C10 & D1) and one cracked (C7) drywall joints, and 3 un-cracked drywall sheets (C2,C6 & D2) to temperature and humidity-induced, climatological effects. Indiana information is on the left and Florida information is on the right. Variation in temperature and humidity inside and out is presented on the bottom. Joint, crack and sheet responses are plotted to the same scale at the top for comparison.

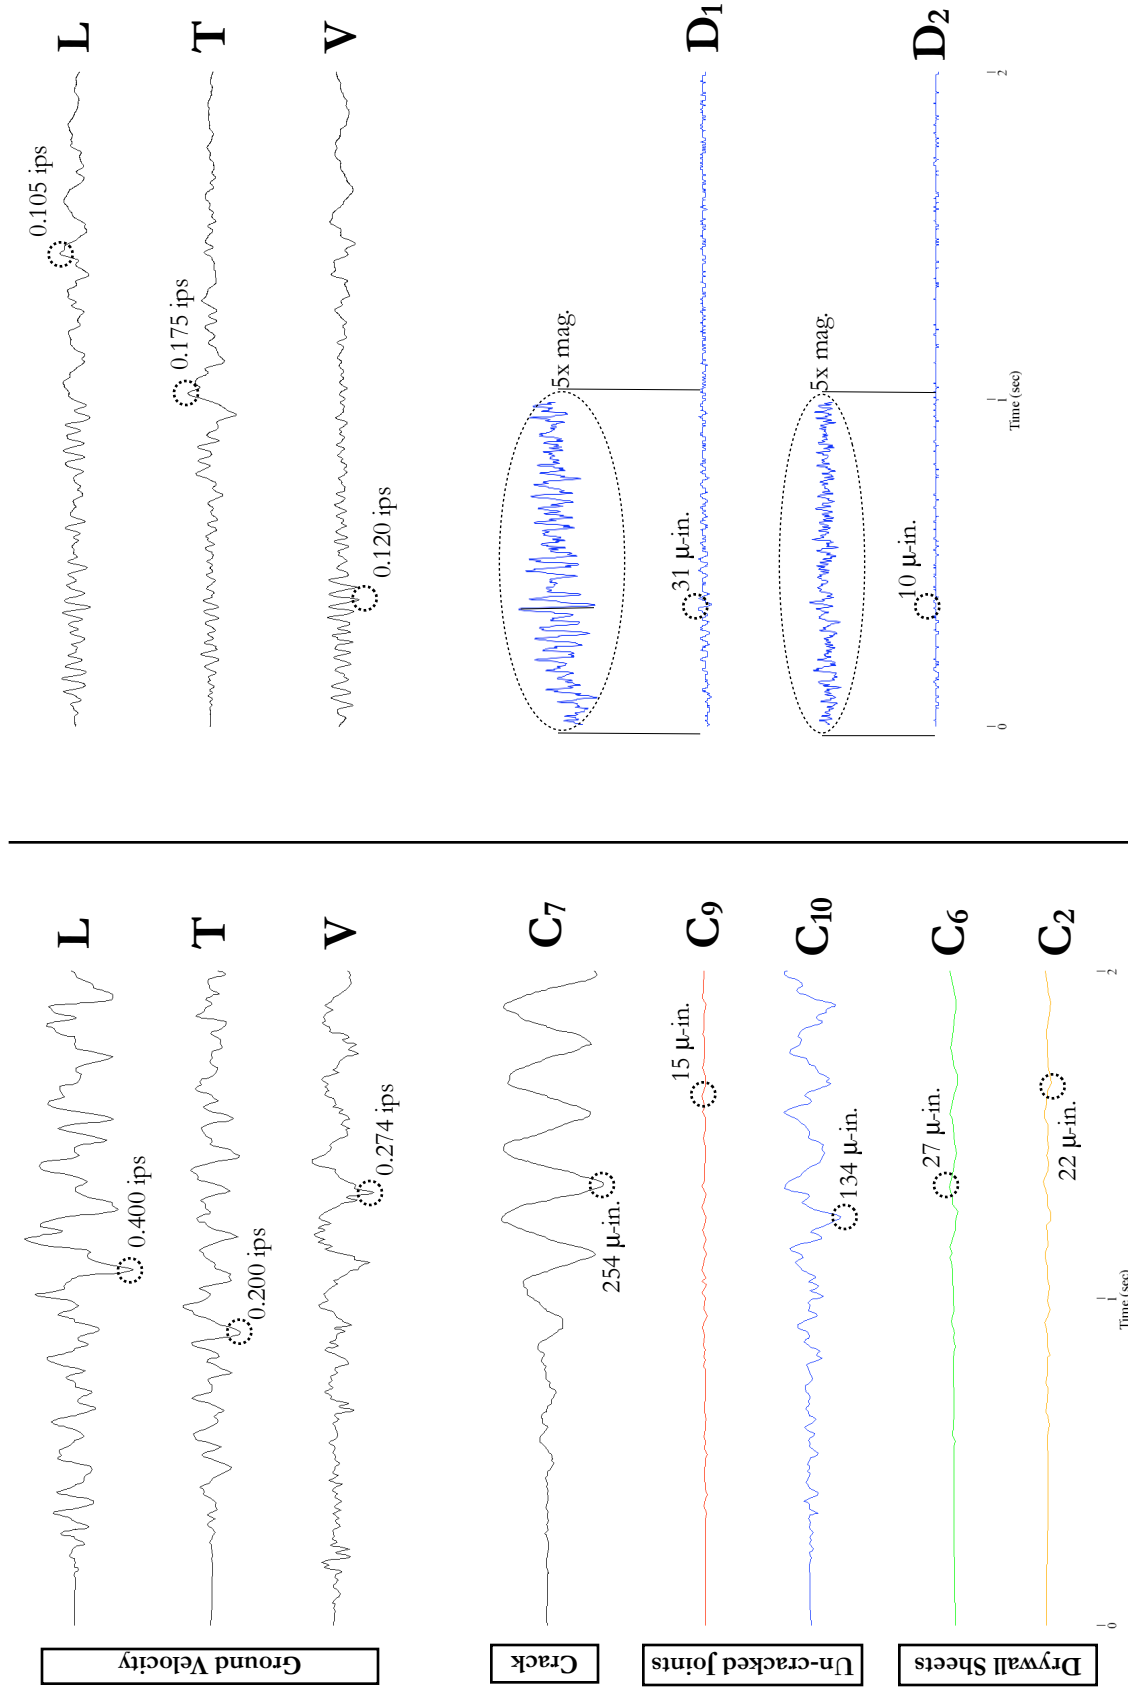
**Figure 5 - Comparison of ground motions (top) with joint responses (bottom) showing unusually low excitation frequency of the Indiana ground motions (left) compared to Florida (right). Cracked joint responds more than most sensitive un-cracked joint.**

Vibratory response time histories of un-cracked and cracked dry wall joints for these two houses are shown in Figure 5. As before Indiana is on the left and Florida is on the right. Particle velocity and air over pressures time histories of the motions that induce the responses are shown at the top and the responses are shown at the bottom. The vertical Indiana drywall joint C10 responds the most – of all uncracked dry wall joints -- and is far more responsive than the horizontal joint. However, its response is still smaller than that for the cracked joint, C7. Response of the Florida drywall joint to ground motions is small and barely out of the noise level. The low frequency ground motions at the Indiana house are evident. Their significance will be discussed in the next section.

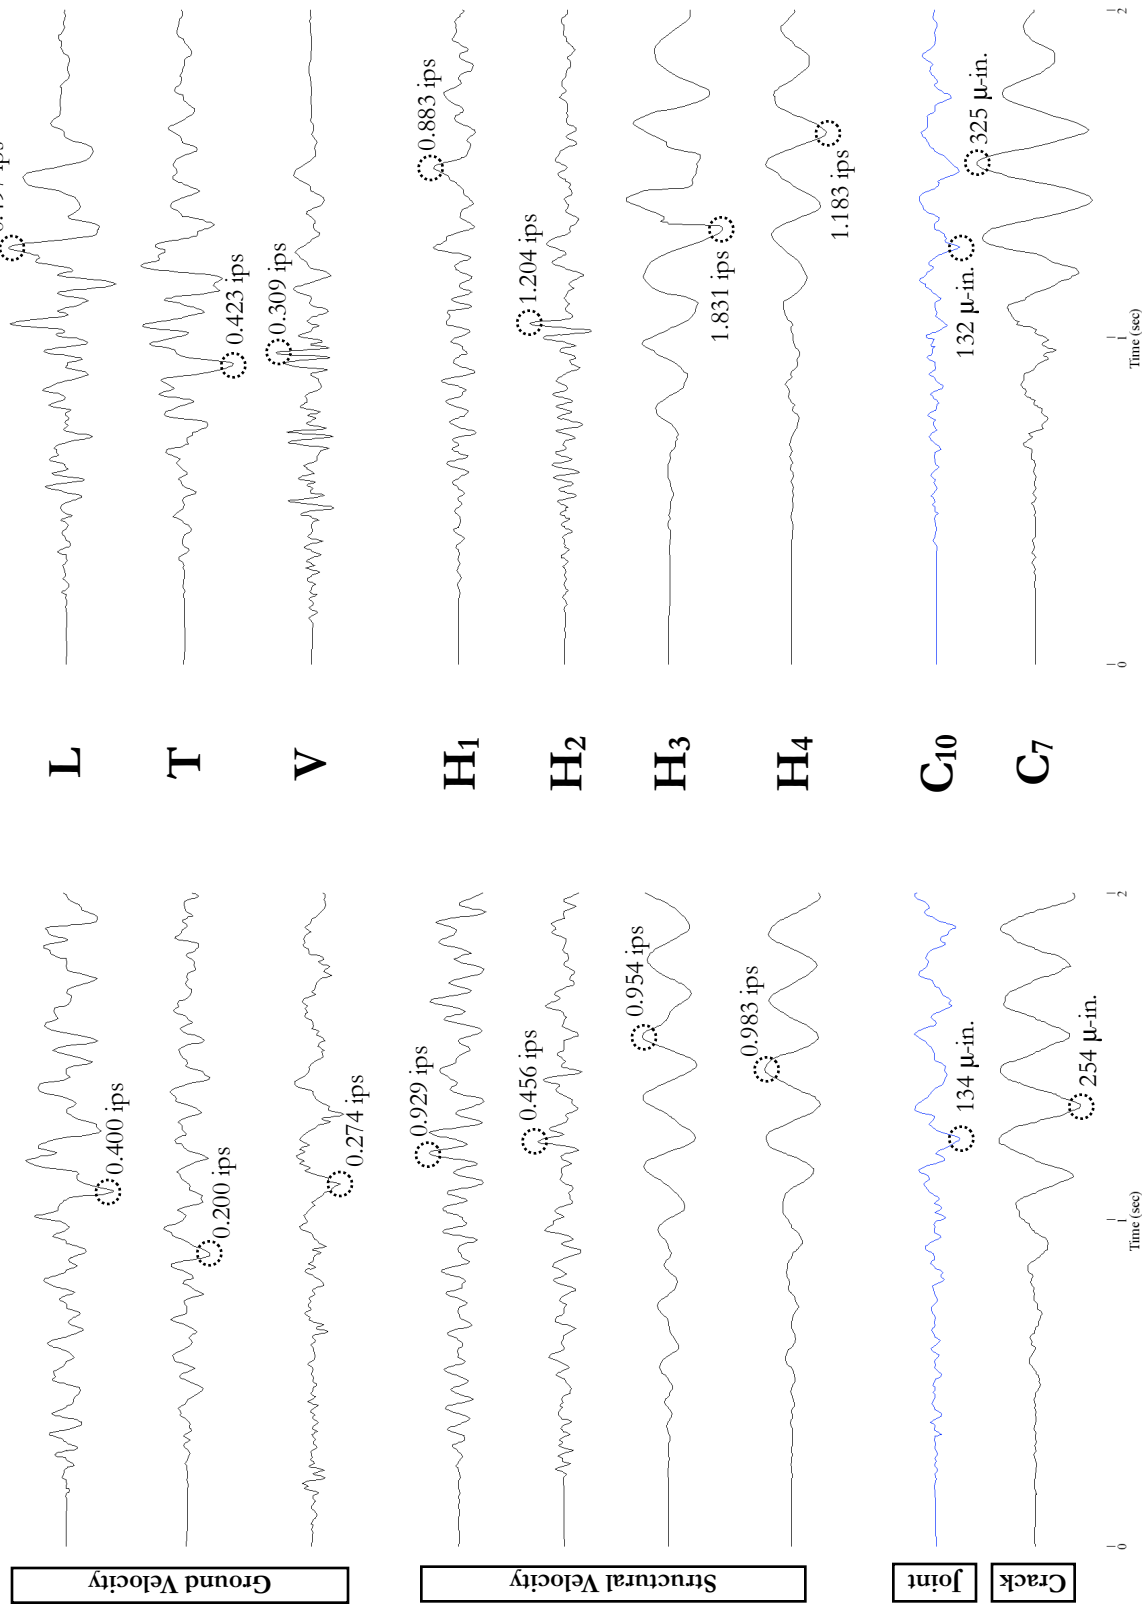
**Figure 7** - Time histories of ground motion, structural response, and cracked (C7) and un-cracked drywall joint response (C10). Low frequency excitation show joint response follows the motion of the upper story. April2nd on the left and May 1st on the right.

Table 1 allows confirmation of several important issues regarding frequency, amplitude and amplification. Figure 7 presents time histories ground motion, wall (H1 & H2) and superstructure (H3 & H4), and C10 and C7 responses responses for shots 12 and 16 that demonstrate some of the following comments. First, amplification values from low peak particle velocity motions (PPV's) cannot be assumed to be applicable for high PPV's. Second, both of the horizontal components must be considered.

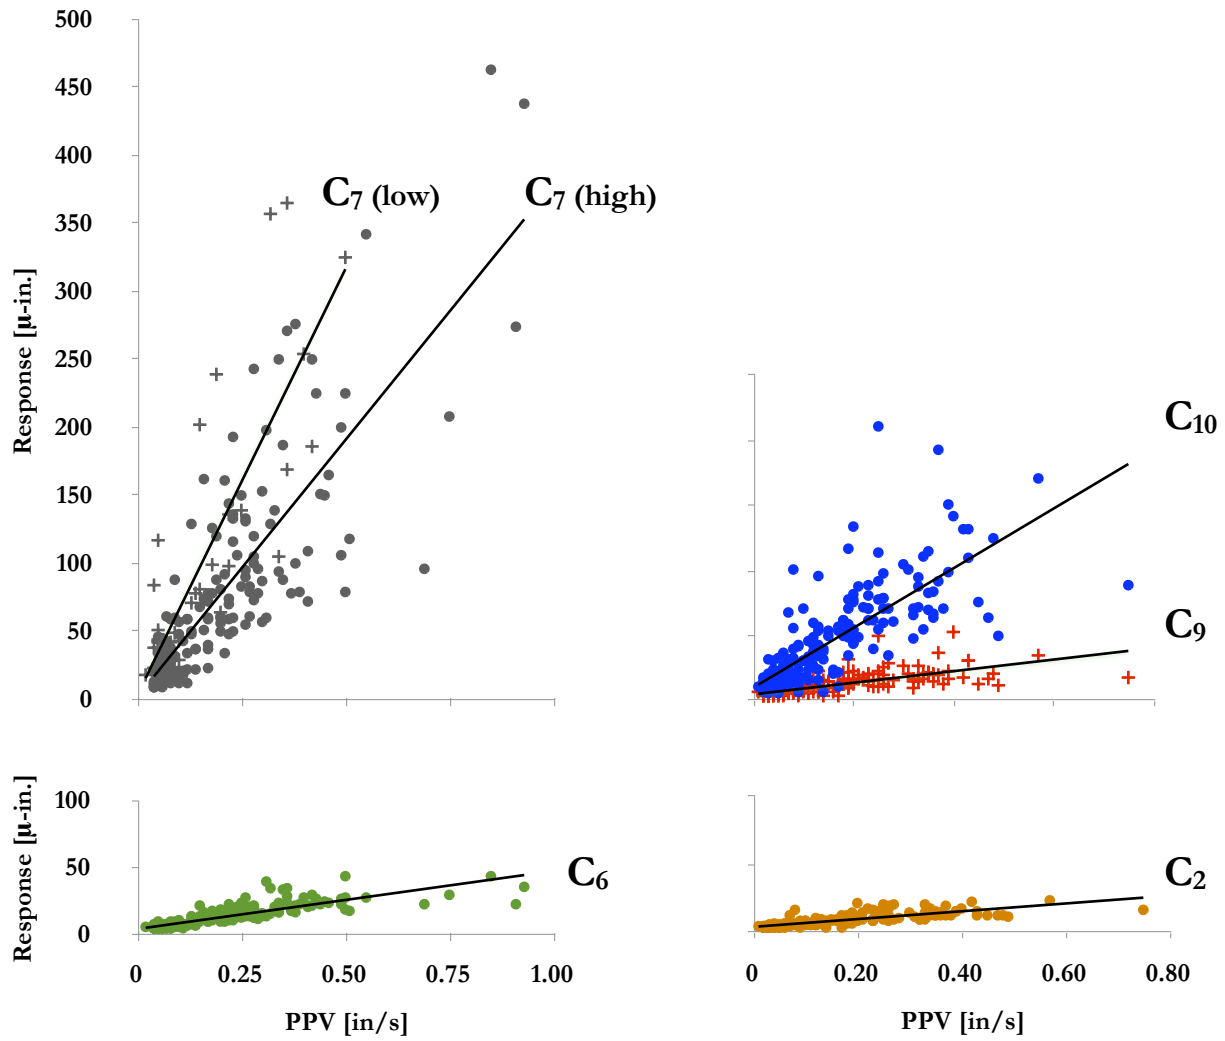
**Figure 8** - Comparison of joint and crack response to increasing peak particle velocity in the direction of the wall containing the crack showing that cracks are the most responsive positions of those instrumented.

Figure 8 graphically compares responses of the 5 measured locations with the maximum PPV in the direction parallel to the wall of interest. They are remarkably consistent and show the same trends that were measured in previous crack-structural response studies that summarized Office of Surface Mining work (Aimone-Martin et al, 2002). Cracks continue to respond more than do un-cracked weaknesses as can be seen by the comparison of C7 and C10's sensitivity to PPV (slope) as also tabulated in Table 1. Here the cracked joint sensitivity is approximately 3 times greater than that for the un-cracked joint even for low dominant frequency ground motions.

These measurements show in Figure 8 that even for high PPV (10 to 23 mm/s or 0.4 to 0.9 ips) and a mix of low (4 to 8 Hz) and higher frequency (9 to 28) excitation motions response of the cracked tape joint, C7, is the same as observed for other vibratory environments. Response follows a

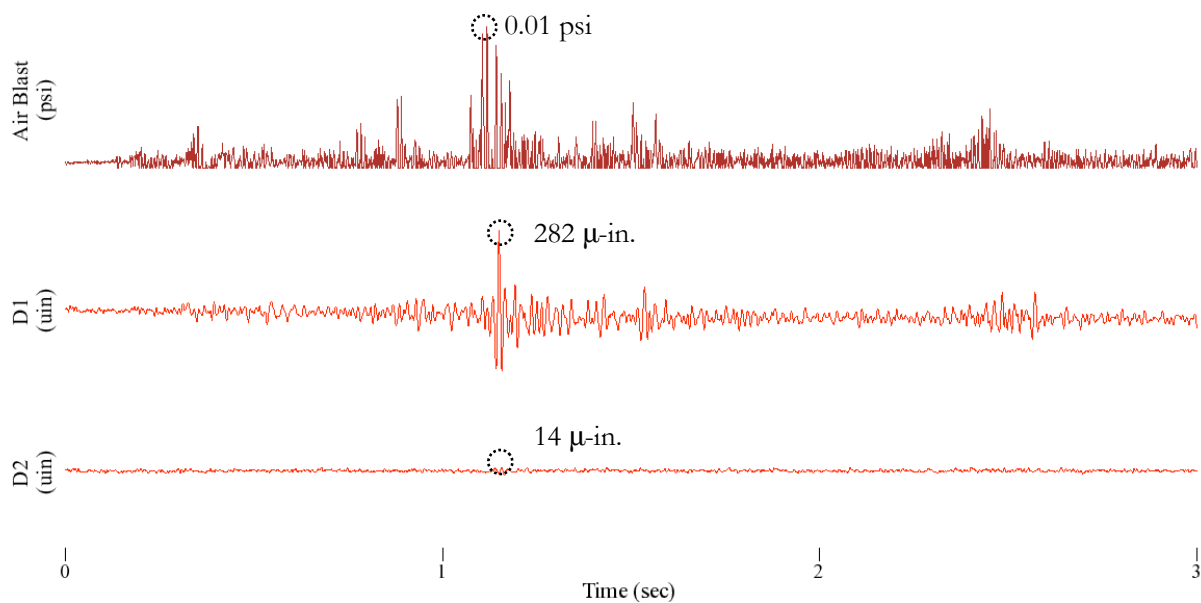
**Figure A-1** - Response time histories during a thunder event on September 5th, 2009. The cracks respond directly to the very large air overpressure.

The uncracked joint and panel also respond to events like lightning strikes that cause a forceful air overpressure. In Figure A-1 below, the drywall joint responds 282  $\mu$ -in, much more than during any blast. Also, note that the air overpressure from the thunder clap (0.01 psi) is ten times greater than any blast in the study period.
